SUZUKI
2-Stroke
Service Bulletin
Index

Bulletin No: GT-1
Date: May 1, 1975

Subject GT750 COOLING SYSTEM

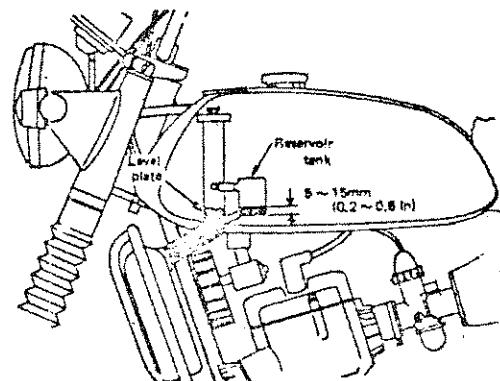
Cooling solution level

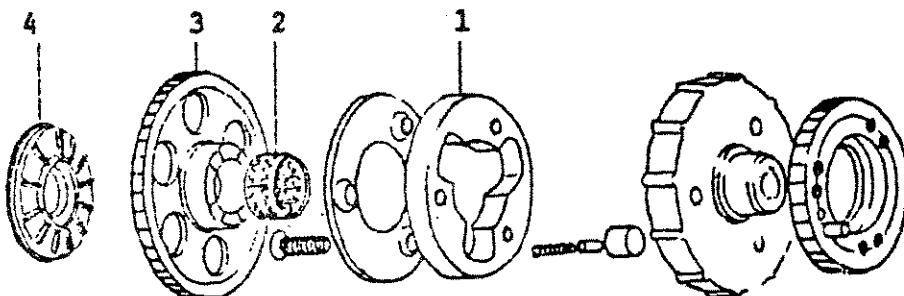
STARTER CLUTCH ASSEMBLY

Reports have been received of starter clutch failures on the subject models. While the symptoms are similar, there have been various contributory factors involved. Therefore, several modifications have been made to effect a total cure, as the following illustrations show.

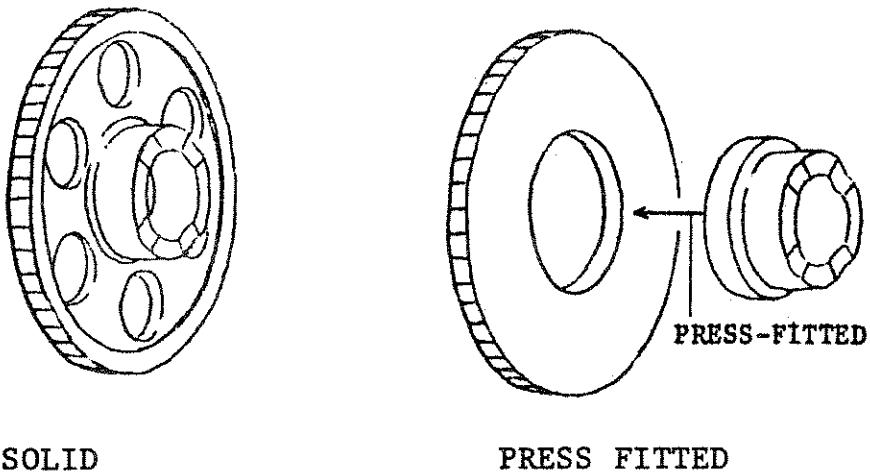
The hub on the starter clutch gear on which the starter clutch rollers run has been changed from a solid type to a press-fitted type as shown below.

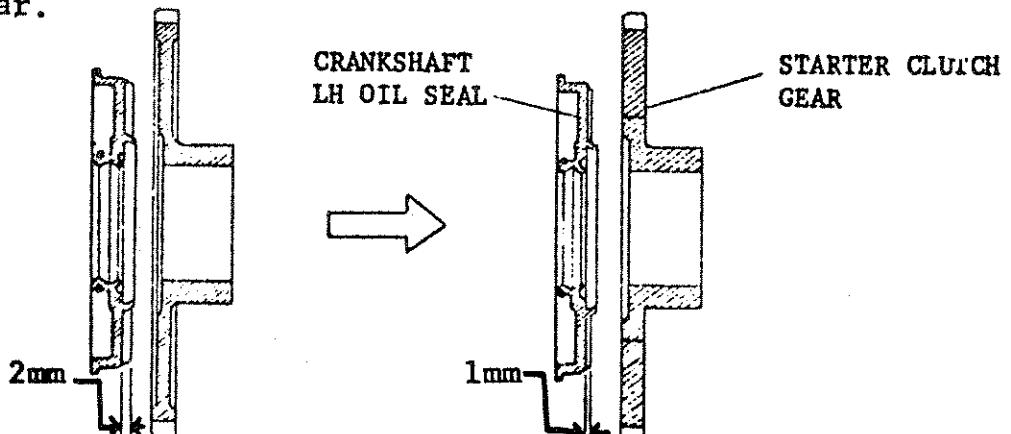
4. CRANKSHAFT LH OIL SEAL

In addition, the height of the ribs on the crankshaft oil seal have been lowered by 1 mm in order to clear the starter clutch gear.

The parts, except the crankshaft oil seal, may be interchanged. However, it is still highly recommended to use only the modified parts in order to thoroughly avoid a possible problem.

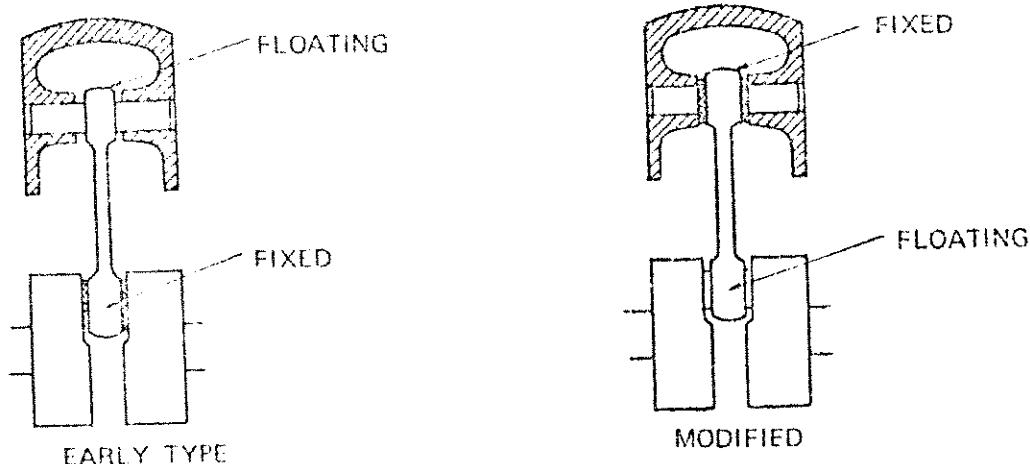
Side movement of the connecting rod is restricted on the small end, and the big end has been changed to a floating type as shown in the illustration below.

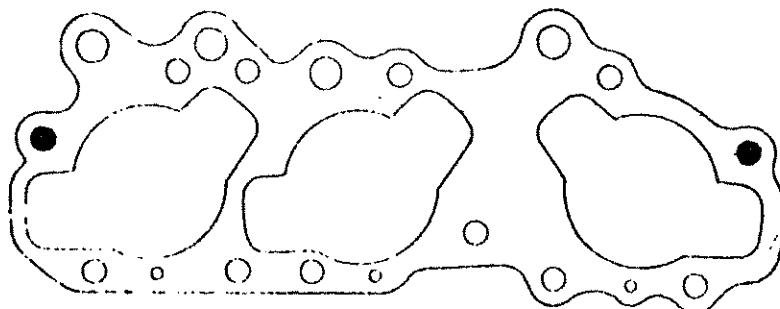
Two holes in the gasket have been enlarged from 11mm to 12.5mm in diameter to match the new type stud bolts.

● : ENLARGED

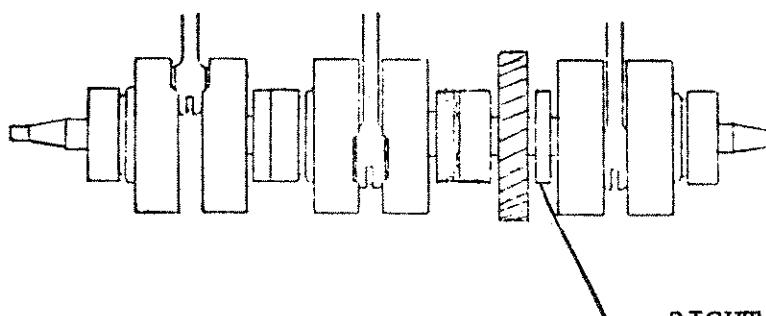
RIGHT INBOARD
CRANKSHAFT OIL SEAL (cont.)

The excessive smoking was attributed to the right inboard crankshaft oil seal becoming displaced, allowing transmission oil to pass into the right cylinders crankcase.

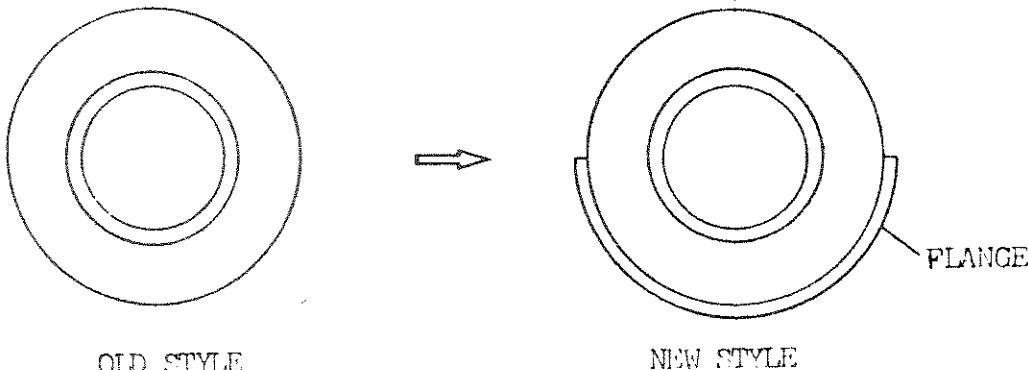
To provide a more positive method of positioning the right inboard oil seal, a metal flange has been added to the seal.

The new style seal's flange eliminates the old style seal's positioning "C"-ring (Part No. 09390-78003). The flange of the oil seal should be placed in the "C"-ring's crankcase groove when positioning the crankshaft assembly in the lower crankcase half.

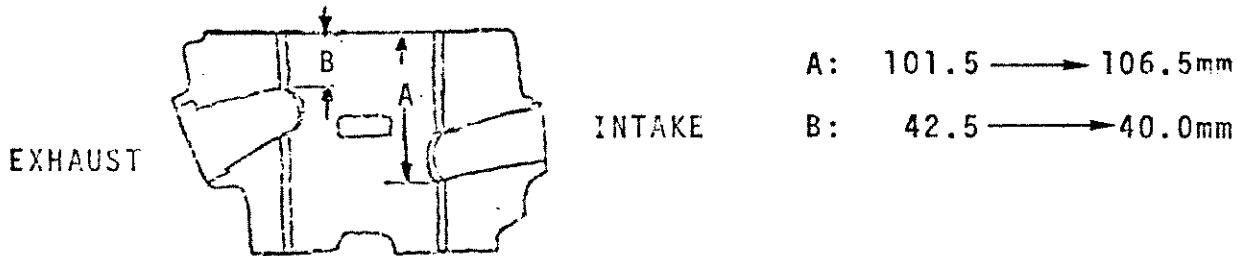
The cylinders intake and exhaust port timing have been changed as indicated.

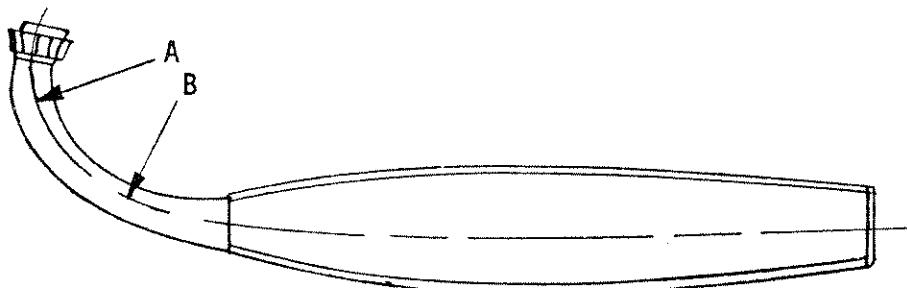
a. Right and Left Outer Mufflers

RADIUS A: 100→90 mm
RADIUS B: 140→165mm

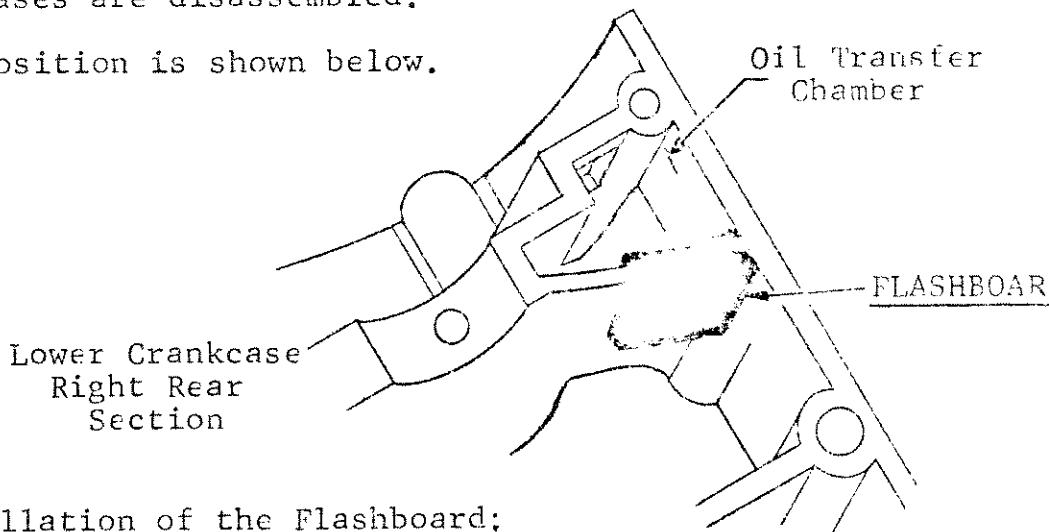
To increase the transmission oil capacity of GT380's prior to the 1974 "L" model to 1500cc, a rubber flashback must be applied to the primary oil transfer chamber located near the right rear of the lower crankcase half. The flashback is now available from U. S. Suzuki's Parts Department and its use is strongly recommended whenever the crankcases are disassembled.

The flashback in position is shown below.

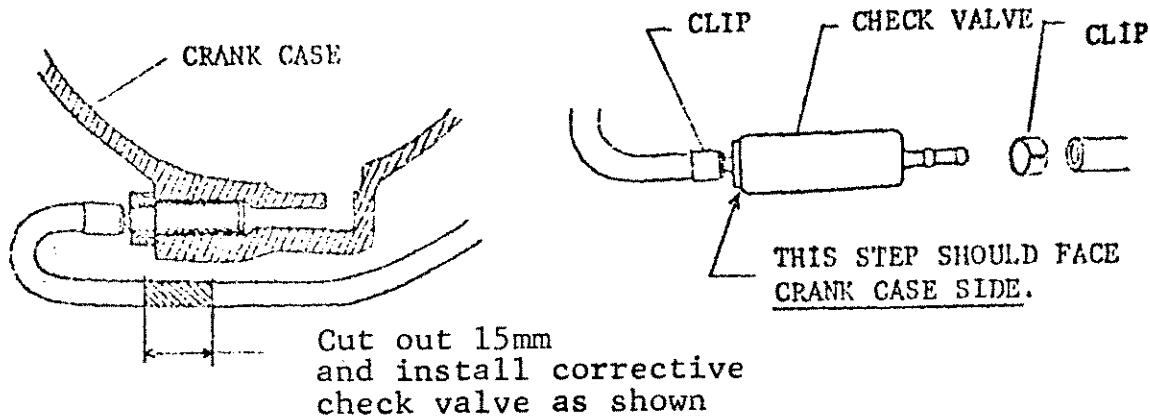
As you may be aware, the K series GT models have had an oil strainer added to the SRIS check valve in order to prevent clogging of the valve and consequently excessive smoking of the motorcycle. Also the valve has been changed from a press fitted type to that of a threaded type. However, the original strainer being constructed of a plastic material, has been found unable to withstand the high speed riding. Therefore, the plastic oil strainer material has been changed to metal.

In order to prevent any J model SRIS valves from clogging, the following modification can be performed as shown below:

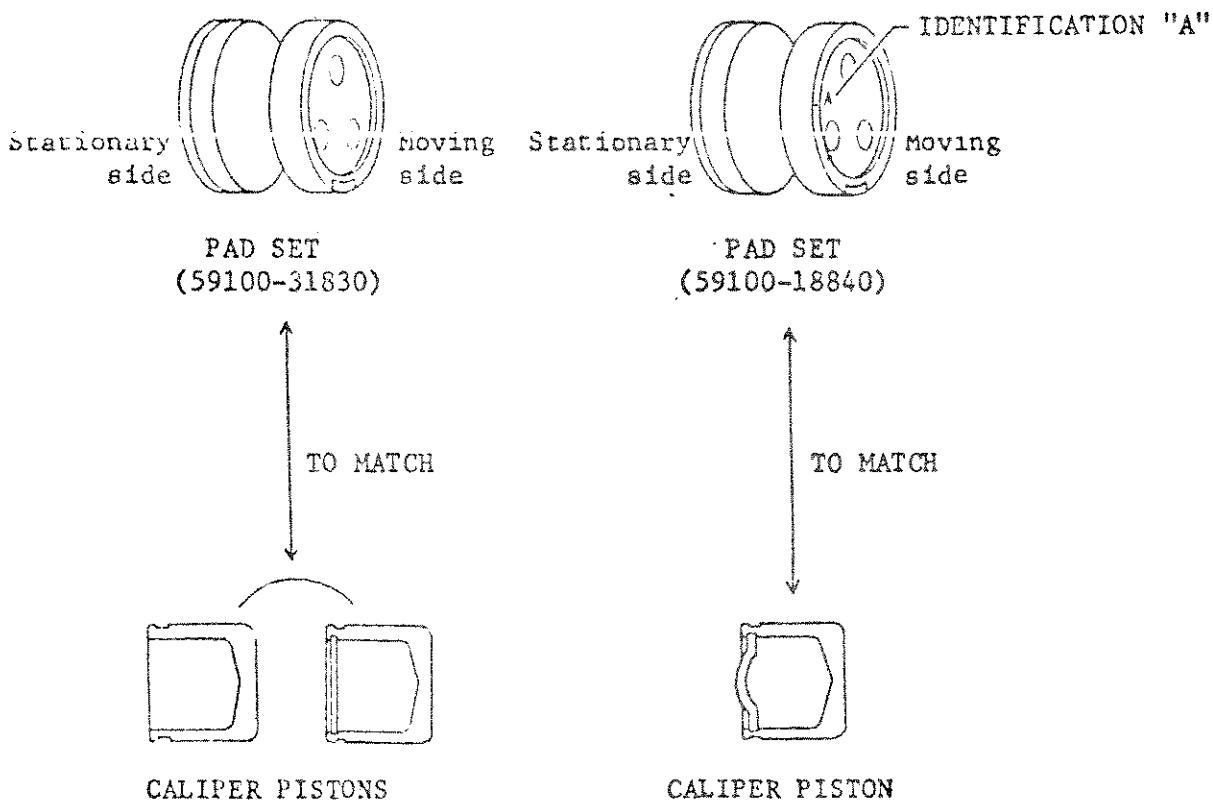
Two pad sets are supplied. Part Number 59100-31830 is for use with the old style pistons. Part Number 59100-18840 is for use with the new style piston. This is illustrated below.

Failure to correctly match these parts could cause the pads to crack or the disc wheel to drag severely.

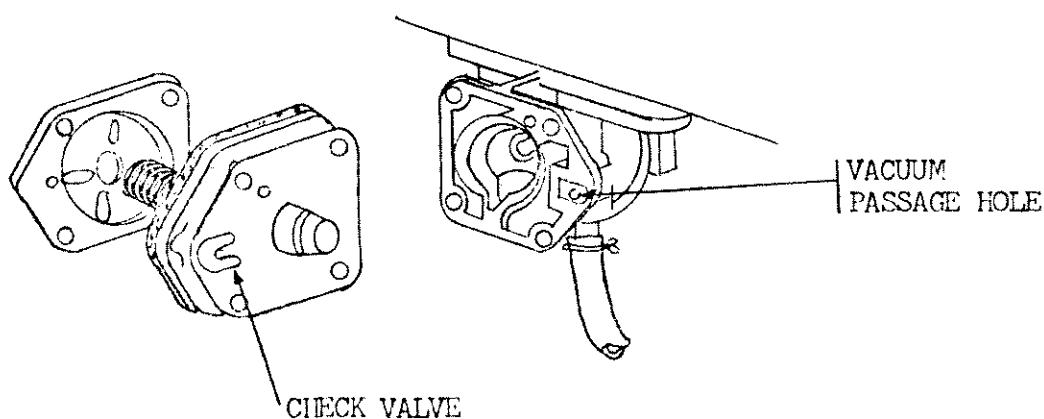
During factory testing, it was found that the new style fuel cock's vacuum passage was being partially blocked by the diaphragm check valve,

1. Remove the fuel tank from the affected unit and empty its contents.
2. Using a #1 Phillips head screw driver, remove the diaphragm cover and diaphragm assembly from the fuel cock's body.
3. Using a 6mm (15/64 in.) bit and drill, chamfer the vacuum passage hole as much as possible without removing any material from the bodies diaphragm mating surface. The vacuum passage hole is shown below.

4. After completing the previous step, use an air hose to remove the aluminum shavings in the vacuum passage.
5. Reassemble the fuel cock, taking care not to damage the diaphragms thin rubber parts and to tighten the diaphragms cover securely.

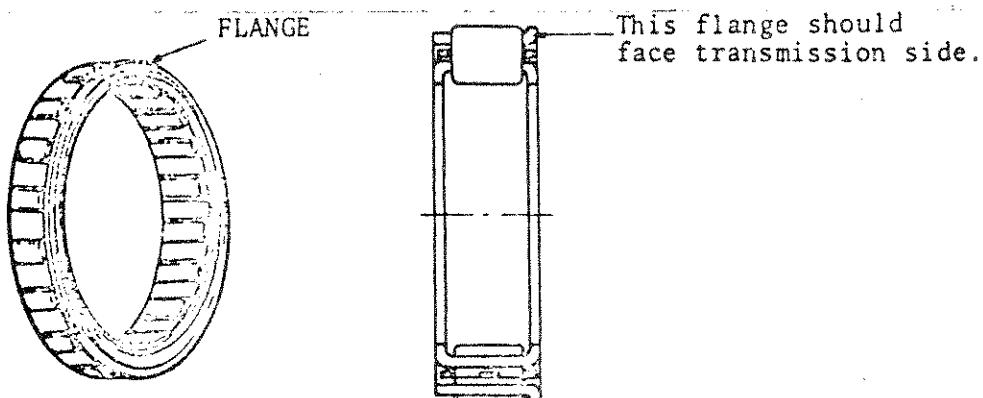
If the one-way clutch is installed inversely, the clutch will not engage when the electric starter is used. If the engine is then started with the kick starter, damage to the starter motor will occur.

Installation of the one-way clutch assembly should be with the flanged side facing the transmission when the primary driven gear is installed on the countershaft.

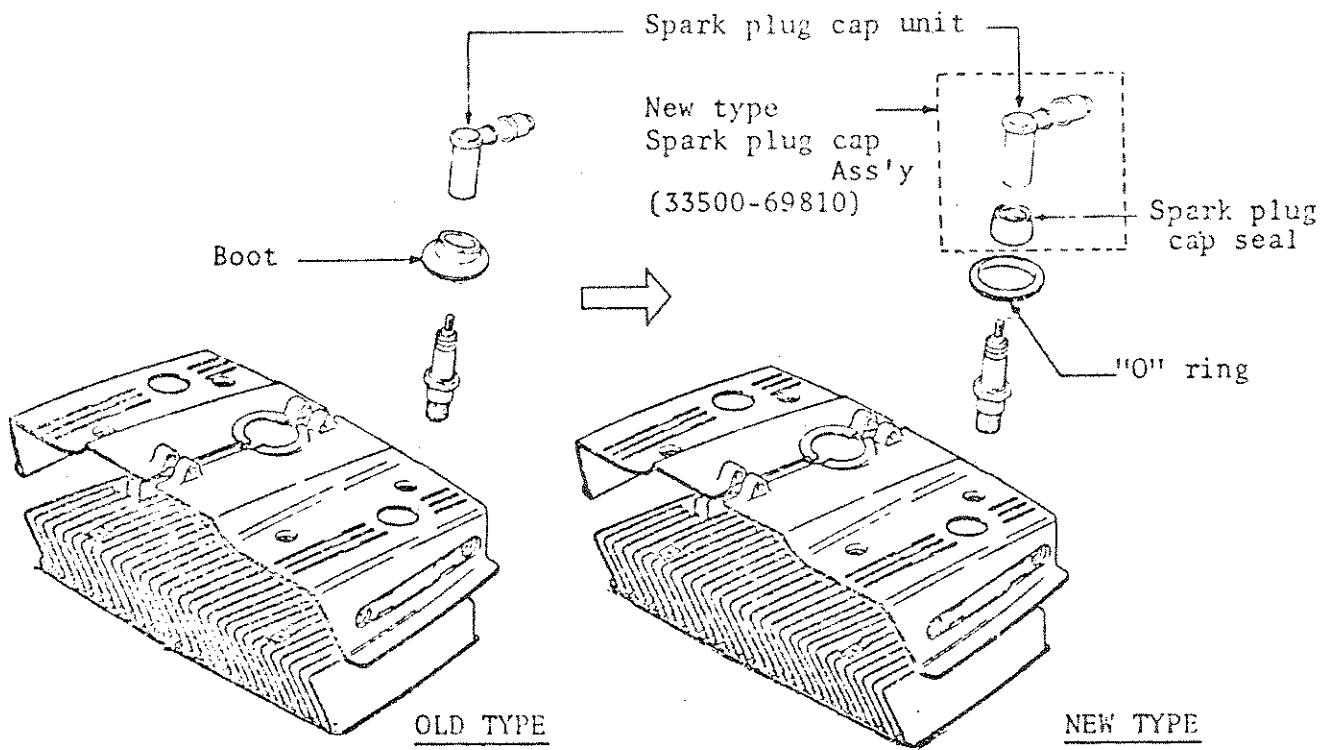
Use of the rubber spark plug cap boot on the GT ram air covers has been discontinued. To take the place of the boot, a spark plug cap seal (also used for other models) and a rubber 'O' ring are now used as shown below.

Whenever a GT model equipped with spark plug cap boots is misfiring, inspect the inside of the spark plug cap unit for "tracking". If it is tracking, replace the spark plug caps and discard the boots, replacing them with the new 'O' rings.

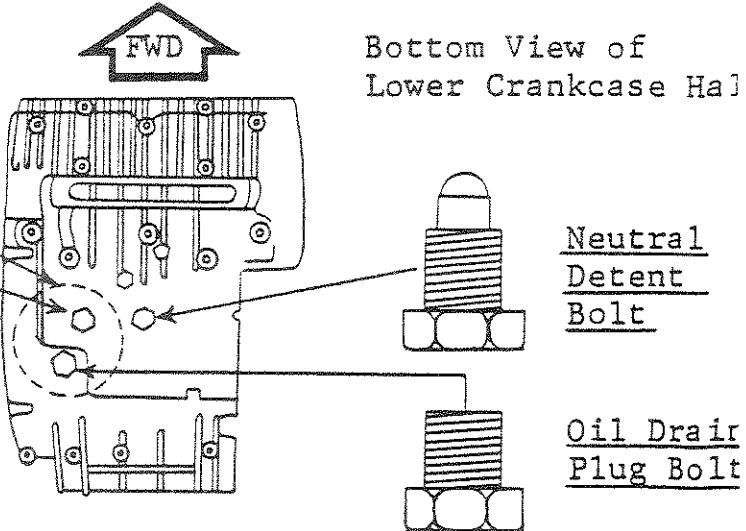
Bottom View of Lower Crankcase Hal

The shift cam guide bolt restricts the shift cam drum from sliding from side to side inside the crankcase assembly. When these two bolts are interchanged, the oil drain plug does not extend into the locating groove of the shift cam drum, allowing the drum to slide from side to side. When this happens the shifting forks slide with the shift cam, allowing two sets of gears to become engaged at the same time. This results in severe damage to the gears, and requires their replacement.
