Suzuki T500 gearbox oil level modification

The following pics demonstrate how the lower crankcase on a pre-1973 T500 needs to be modified to increase the amount of gearbox oil that actually stays in the gearbox.

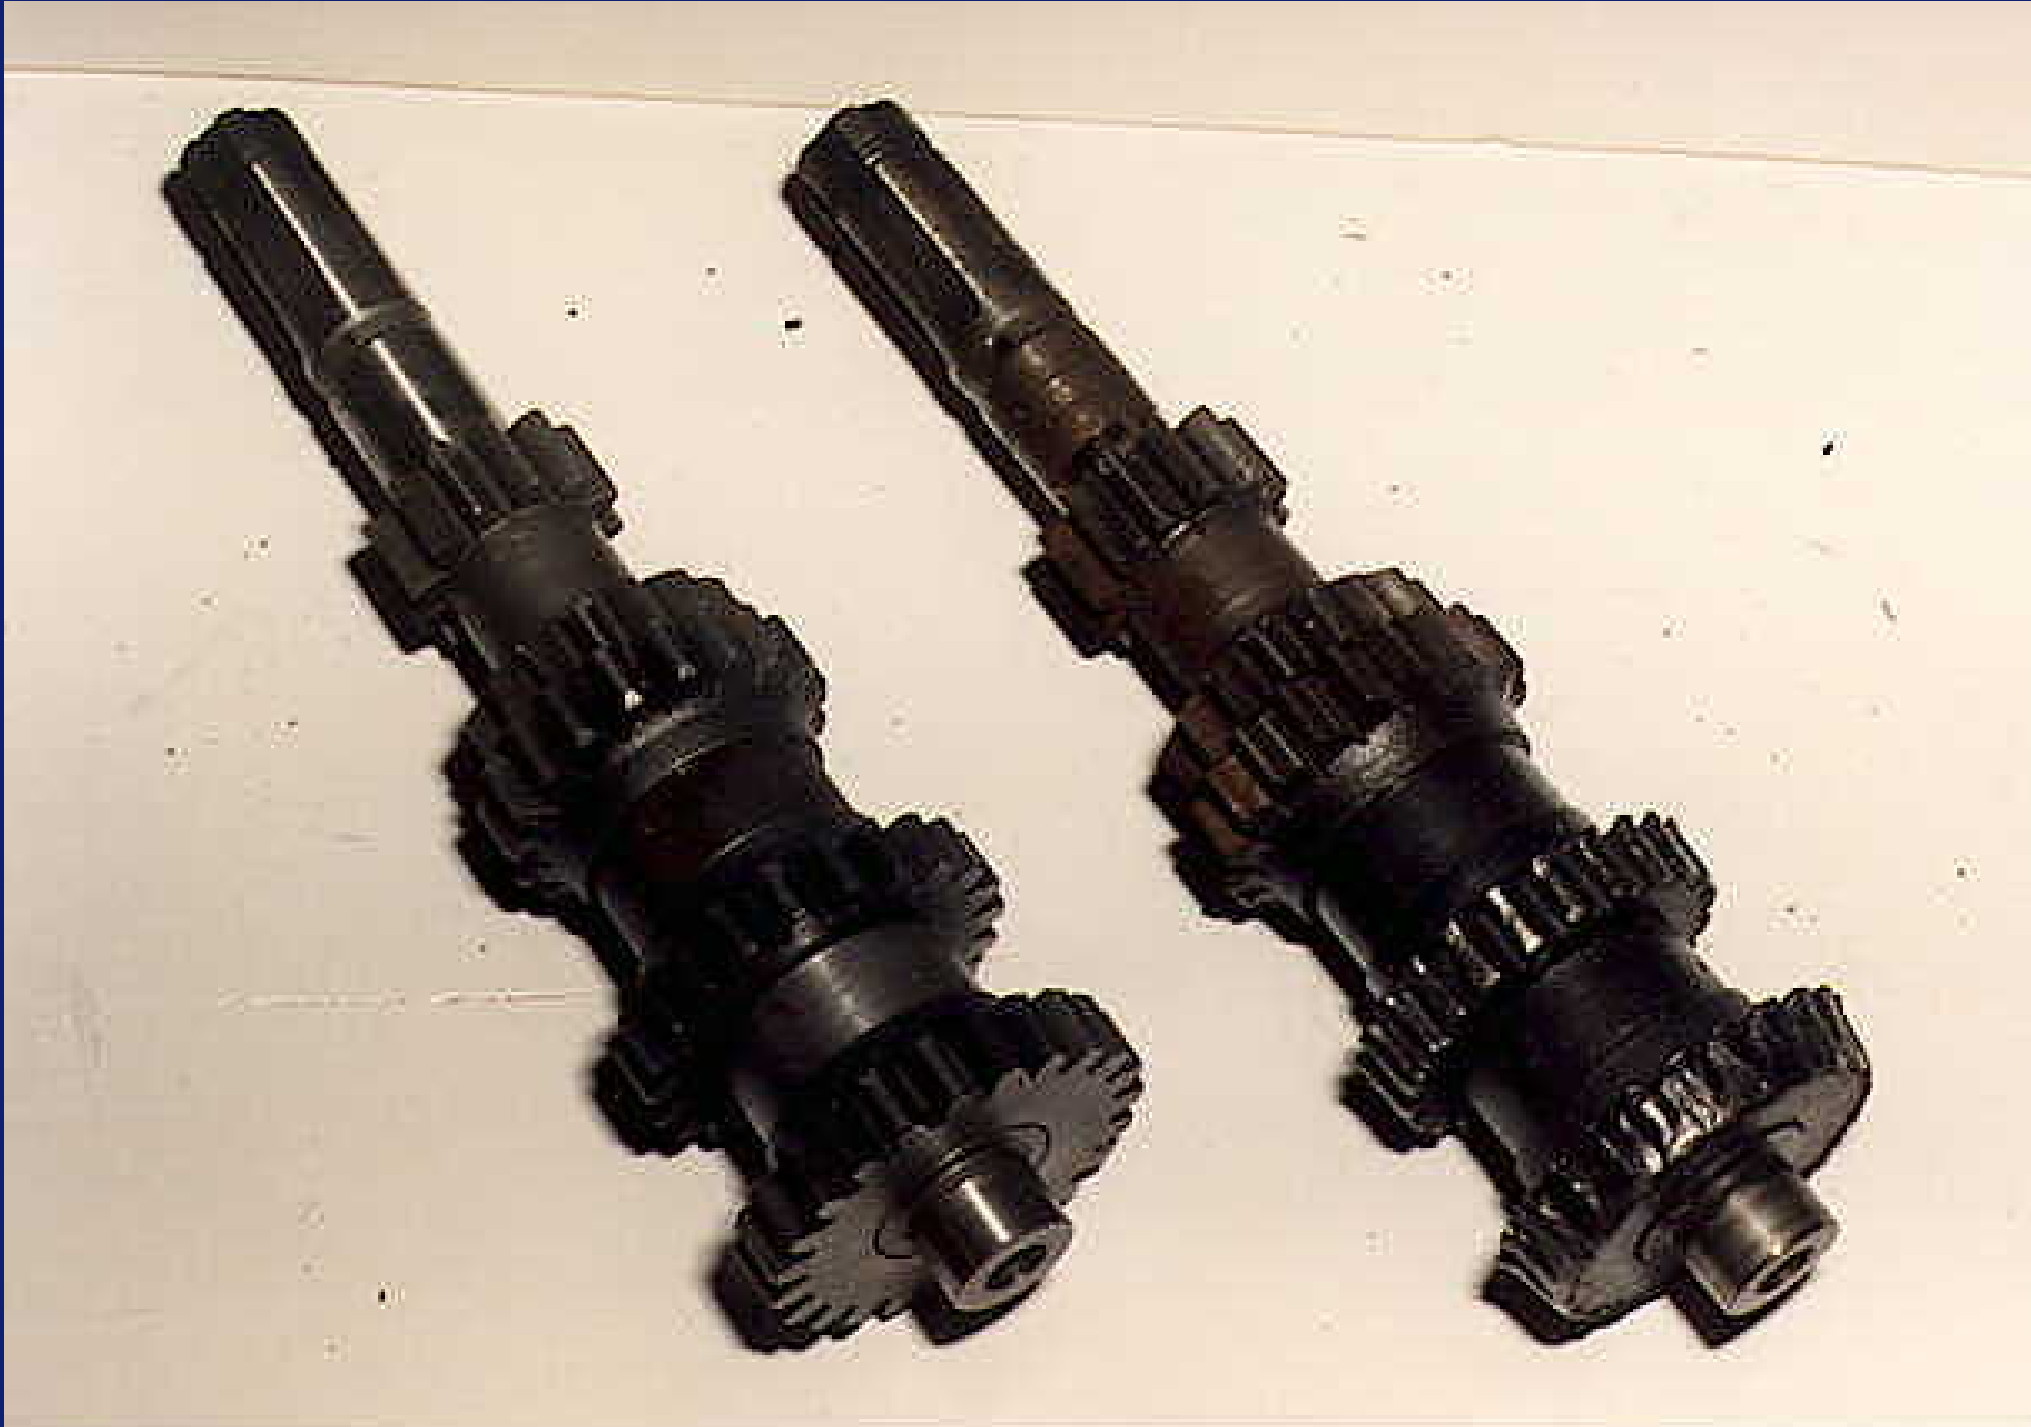
This is what will happen if you don't keep your gearbox level up to 1400cc!!!  
The gear shaft on the left is a new one, the one on the right is an old one with a totally ratshit 4th and 5th gear.

What happens is that of the standard 1200cc of oil that goes into a pre-73 gearbox a fair proportion of it overflows into the clutch case.

Starved of oil the 4th and 5th gears lose their case-hardening and at first become pitted and finally once the hardening is fully eroded, the gear teeth begin to collapse under the heat and pressure. In the meantime the bits of metal don't do much good for the rest of the box either. It is easy to tell when the teeth are going as the box will start to whine and the whole thing eventually sounds like a steam engine clanking away.

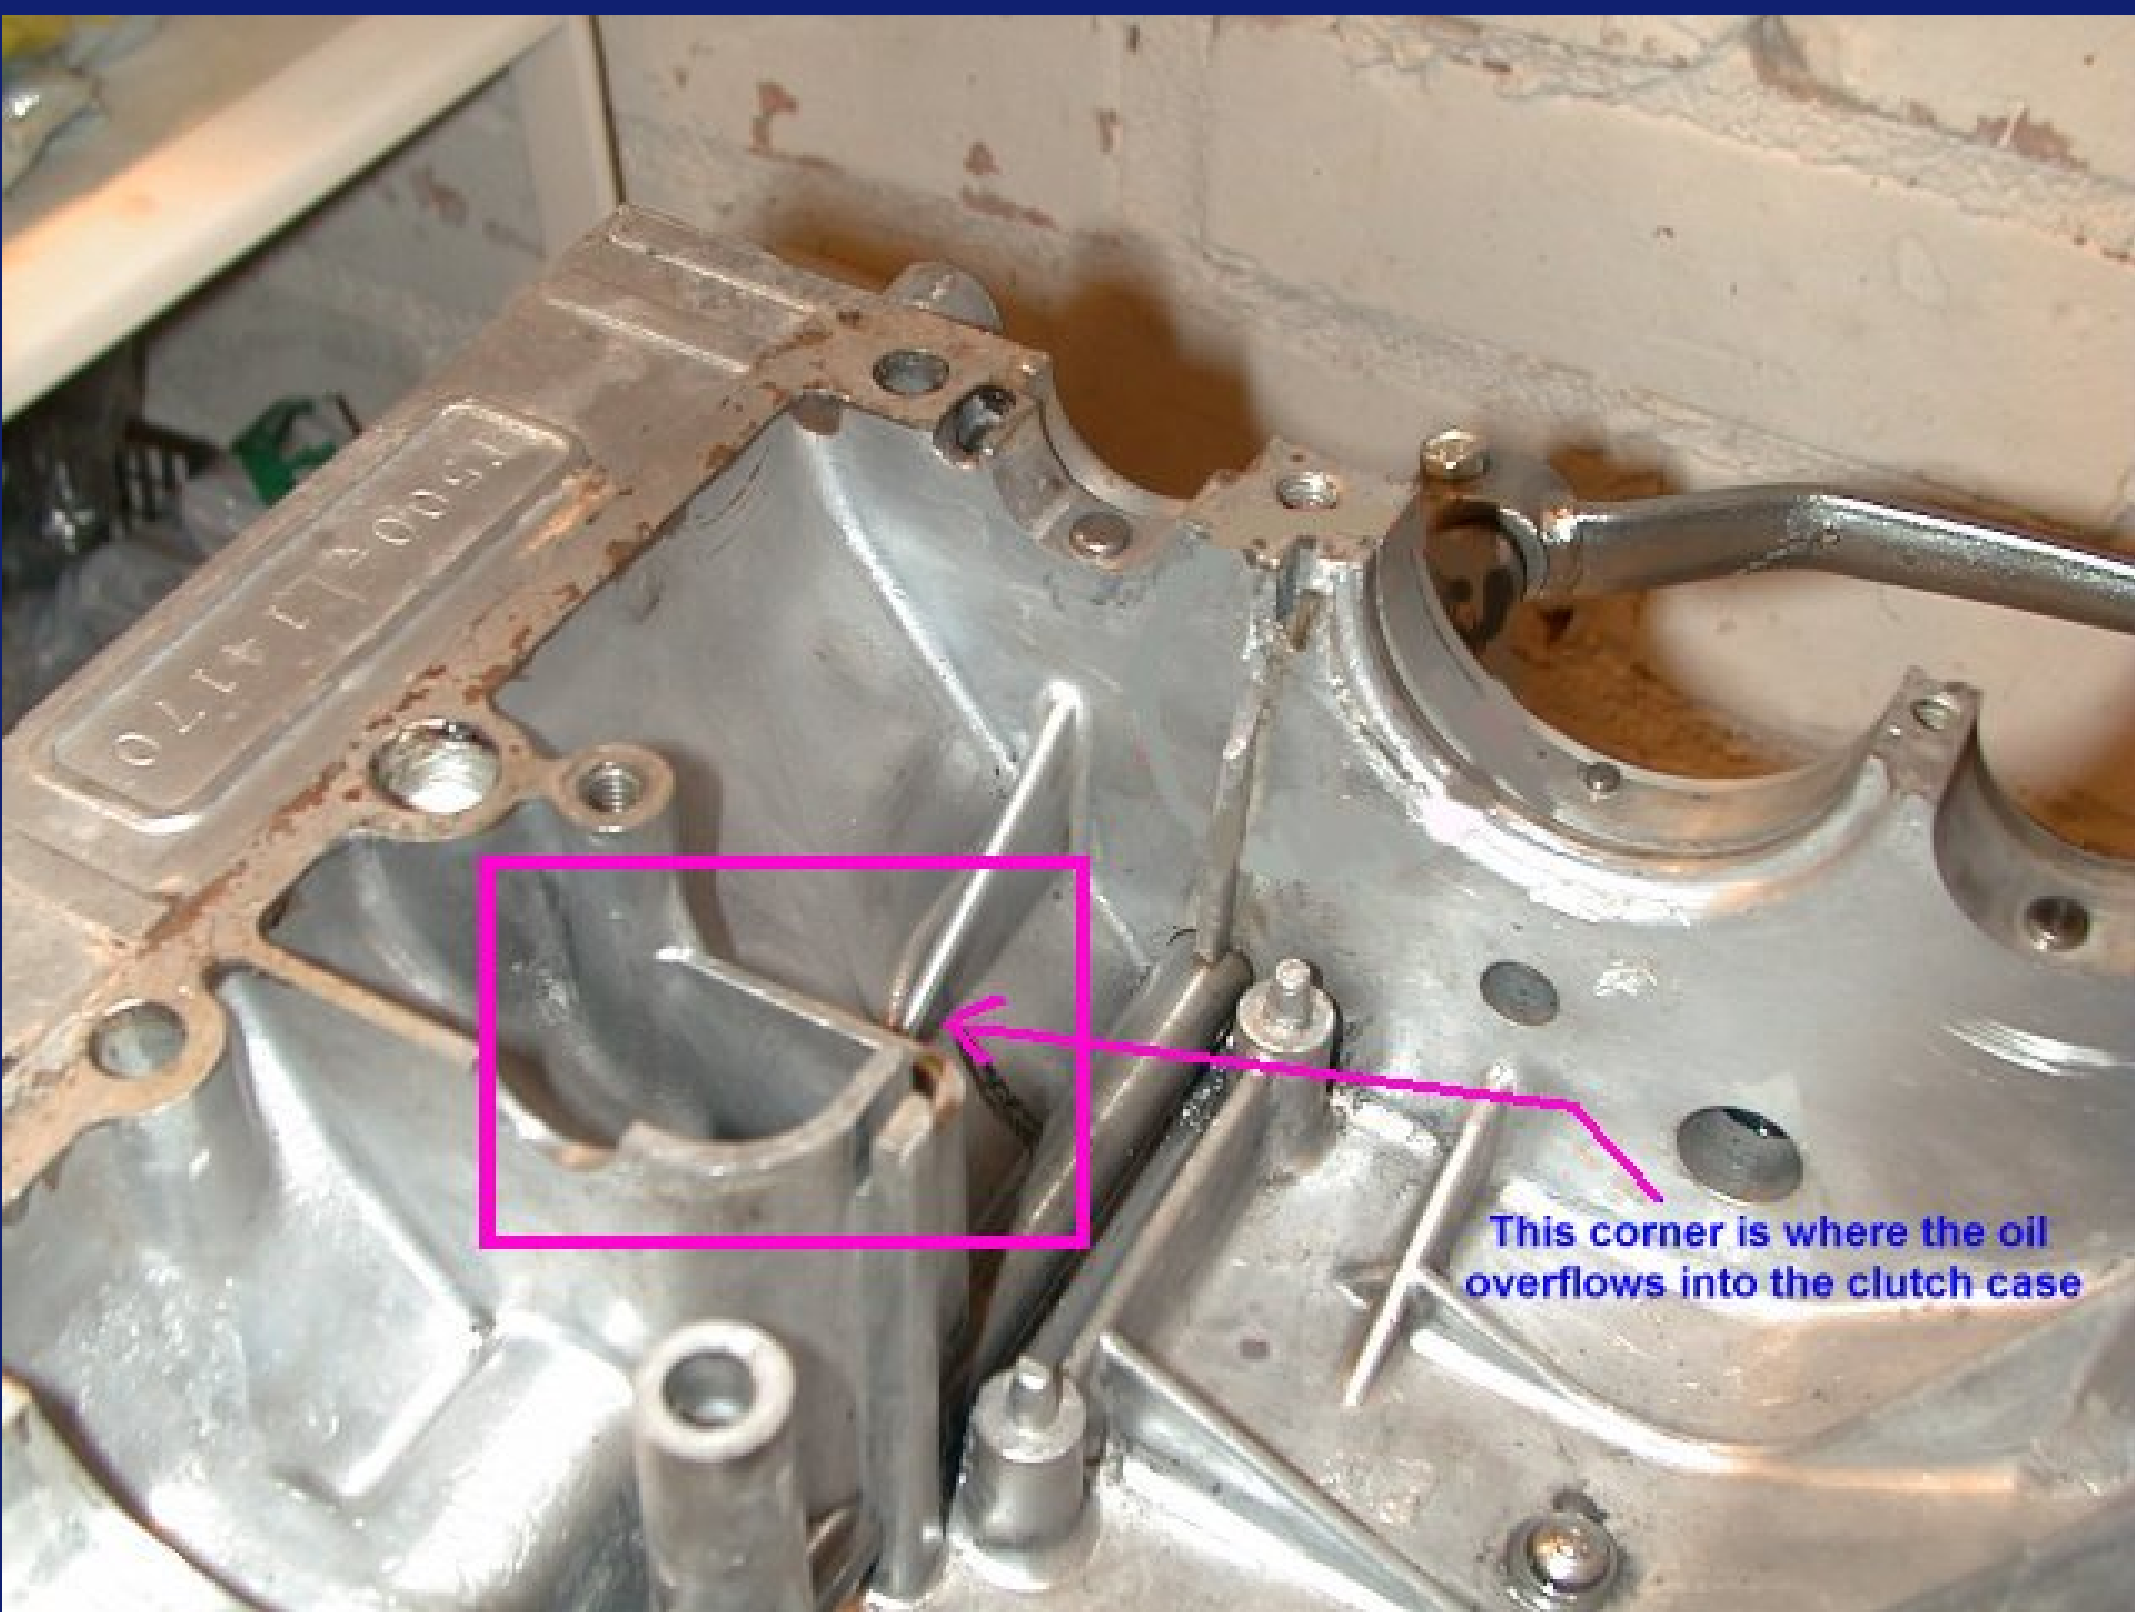
The pic above shows where the problem lies. Back near where the kick starter shaft goes there is a webbing wall which has a indent, this is where the oil overflows to the clutch case.

If you can't source a post 1974 crankcase then you will need to strip your current motor. (The post 1973 crankcases have been modified by the factory to address the problem and they take 1400cc of oil as standard.)

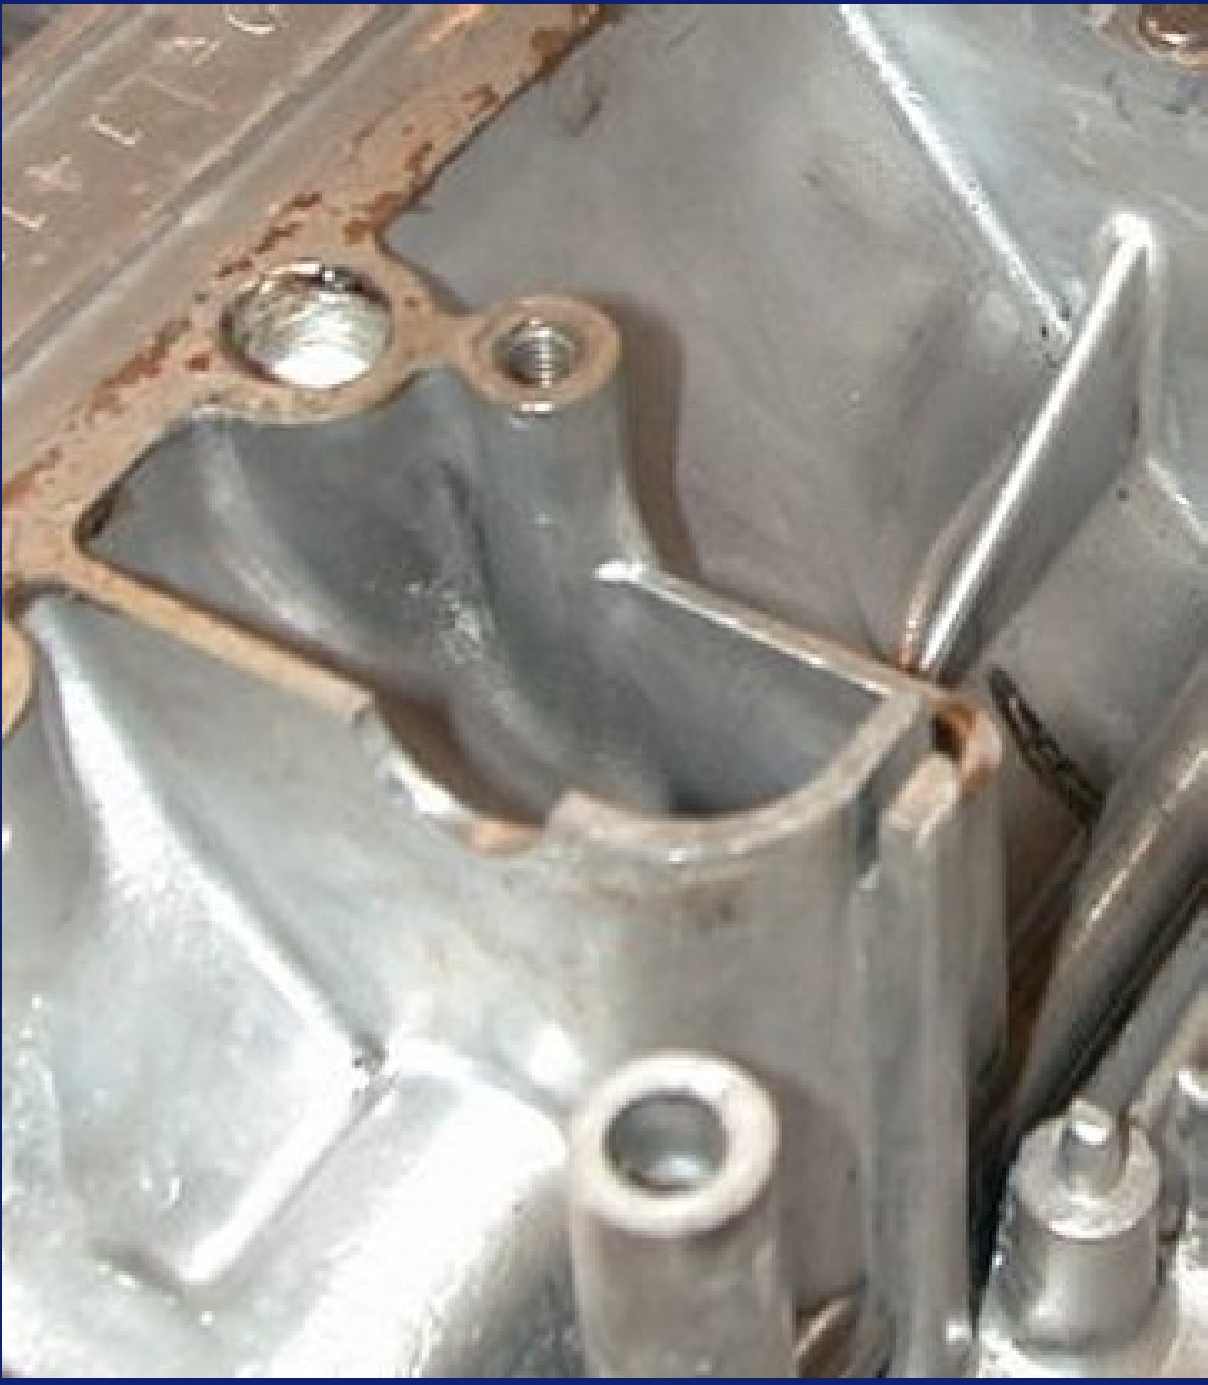
Close up of the overflow wall
