# Service Bulletin

Subject: GT380/550/750 BATTERY BREATHER  
LOCATION

Bulletin No: GT-14

Date: May 1, 1975

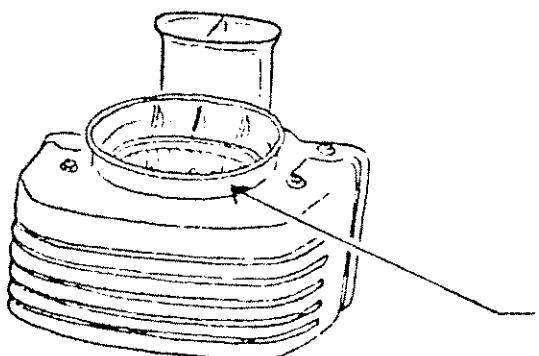
1. OLD TYPE

DO NOT APPLY SUZUKI BOND NO. 4  
ON AIR INLET HOSE, OTHERWISE  
IT MAY CAUSE CLOGGING OF THE  
CARBURETOR.

COAT WITH "SUZUKI BOND NO. 4"  
ALL AROUND.

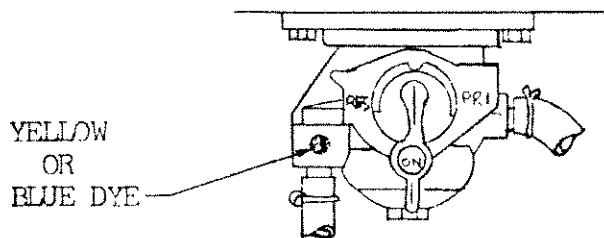
Units having fuel cock assemblies with yellow dye on the vacuum intake side of the body have been corrected at the factory and may be installed on units prior to the Frame Numbers listed below.

All fuel cock assemblies on units after the above Frame Numbers have been corrected and have a blue dye on the vacuum intake side of the body.
