SERVICE BULLETIN

Bulletin No. MC75-1
Date February 14, 1975
Page 1 of 1

SUBJECT: **MODIFIED R.H. CRANKSHAFT OIL SEAL**
Affected Models: **GT750**
Effective Engine No.: **GT750-54214**
Reference:

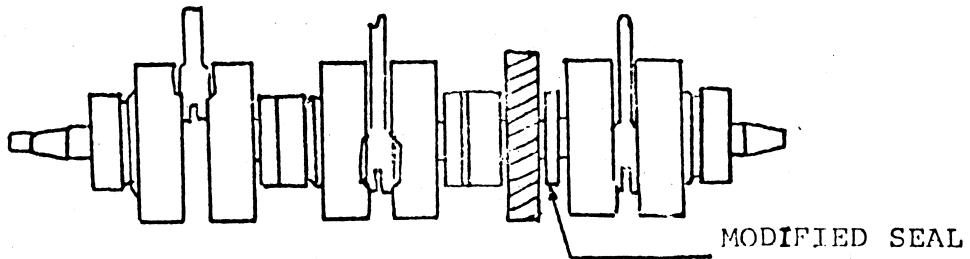
We have received occasional reports of GT750's smoking excessively from the right exhaust pipe.

The excessive smoking was attributed to the right inboard crankshaft oil seal becoming displaced, allowing transmission oil to pass into the right cylinders crankcase.
