SERVICE BULLETIN

RADCO SALES LTD. — TECHNICAL SERVICE

SUBJECT: **MODIFICATION OF SRIS PIPING**
Affected Models: **GT750**

Bulletin No. **117**
Date **Jan 16, 1973**
Page **1** of **3**

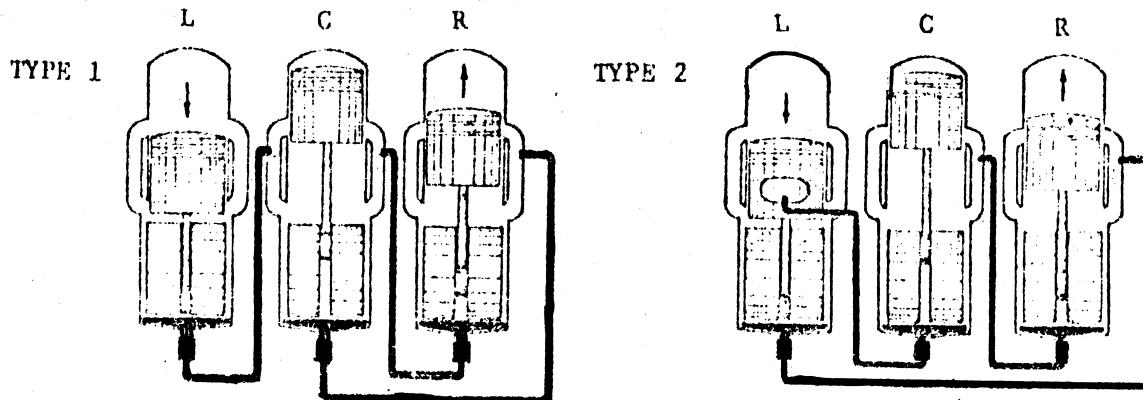
As explained in the Service Manual of GT750, there are two types of the SRIS piping shown below and the type 2 in the illustration has been applied to the production since just before the yearly change of 1973 and the initial number of the modified engine is GT750-31344

The reason for this modification is to rectify the symptom that the engine of the type 1 tends to emit a little thick fumes from the right hand muffler as compared with the others

This symptom only appears when the engine is not warmed up enough and it in no way affects the engine function. However, it is supposed that the users who mainly drive the motorcycles in town or at rather low speeds might point out this problem and request you to correct it.

In order to provide for this request, a modification kit has been prepared to convert the early engine to the new type in principle and it now available as a spare part.

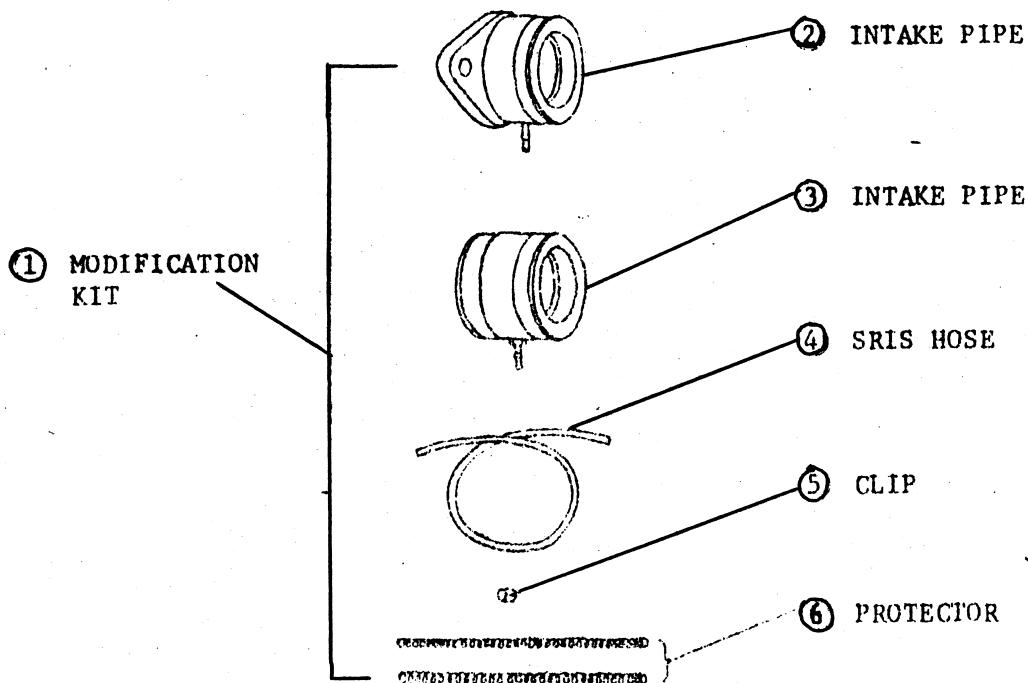
Since the early type engines are classified into two types in respect to the configuration of the intake pipe placed between the cylinder and the carburetor, the modification kit has been provided with two types of intake pipe so that it can be used on both types. Therefore it is necessary to check the type of the engine and use the appropriate intake pipe.

REF NO.	PART NO.	PART NAME	QTY/UNIT
1	13100-31830	SRIS MODIFICATION KIT	1
2	13110-31990	INTAKE PIPE COMP.	
3	13110-31991	INTAKE PIPE COMP.	EITHER ONE OF 2
4	09343-02010	SRIS HOSE	1
5	09410-00042	CLIP	1
6	16871-31000	PROTECTOR	2

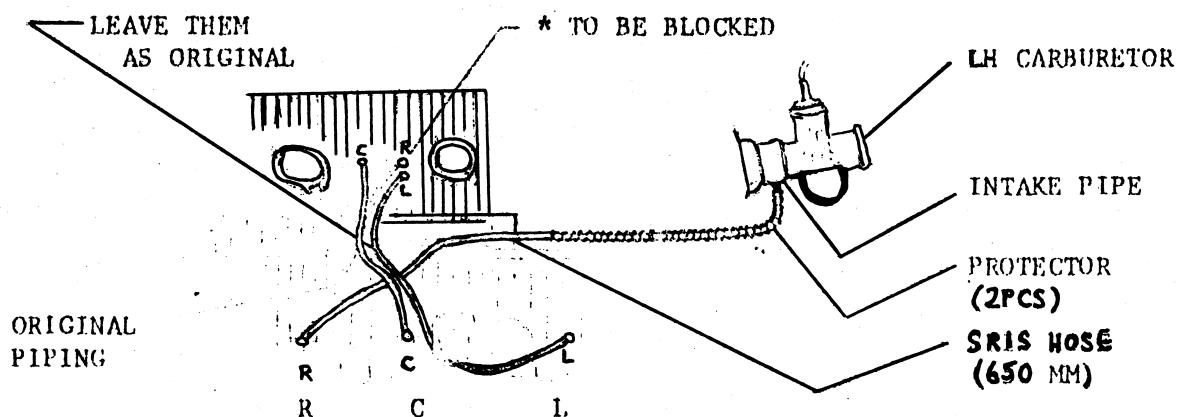
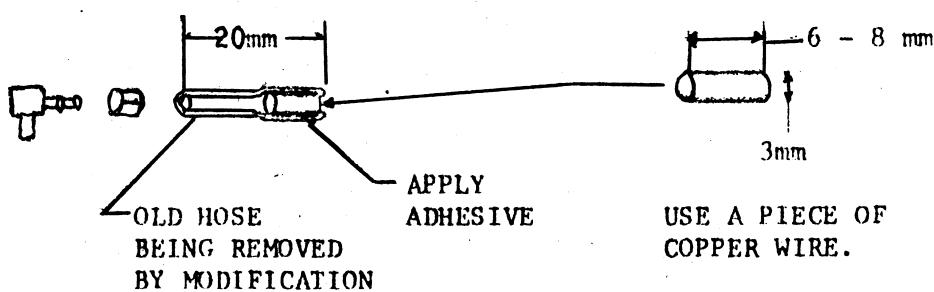
MODIFICATION PROCEDURE

The unbalance of the exhaust fumes is not always due to the construction of SRIS explained previously but to blockage of the SRIS check valve installed on the lower part of the crankcase.

* To block the part shown above, perform the following job.

Therefore, before setting about this modification, it is necessary to examine the function of the check valve and take corrective measures as required.
