SERVICE BULLETIN

SUBJECT: BATTERYS NOT CHARGING
Affected Models: Three Cylinder Models
Effective Engine No.: Before E.#'s GT380-38764
Reference: GT550-27536 & GT750-33504

Bulletin No. 137
Date June 11th 1973
Page 1 2

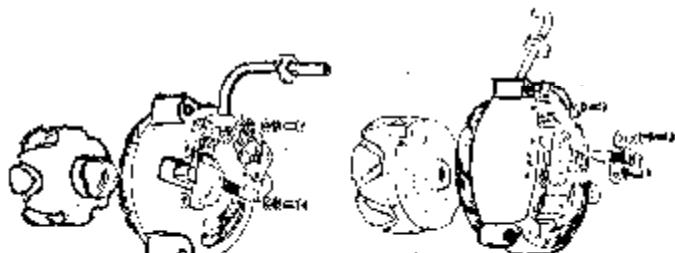
APPEARANCE:

The early rotor coil was wound on a plastic bobbin then taped outside and fitted between the rotor poles with no space allowed for expansion of the coil windings when warm. The new type have their coil wound loose, then taped all around in the same manner as a new tire is wrapped. The coil is fitted with a felt spacer to allow the windings to expand and contract.
