SUZUKI
2-Stroke
Service Bulletin

Bulletin No: General -4

Date: May 1, 1975

Subject: NYLON PLUG MODULES

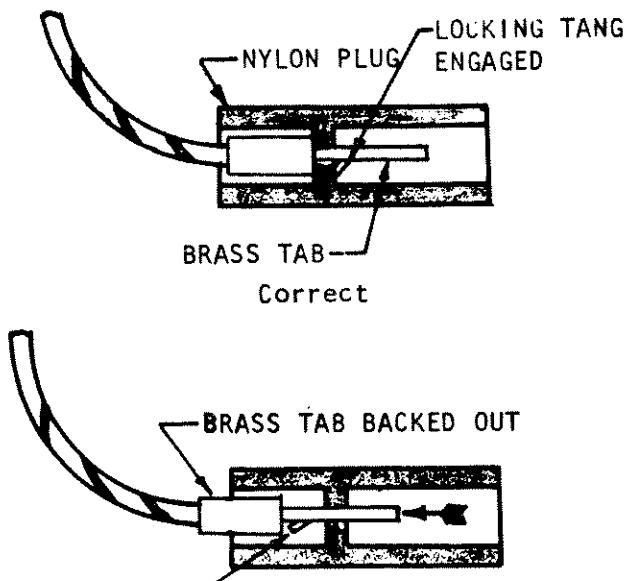
CAUSE: Certain Suzuki models are fitted with quick disconnect electrical plug modules. There are four or five such plugs in the wiring harness, depending on model. The female half of the module incorporates individual brass tabs. When the two plug halves are pressed together, one brass tab may back out of the plug, breaking the circuit.

CORRECTION: Inspect the plastic plugs in the wiring harness. The brass tabs have locking tangs which secure them in the plug body. Press any loose tab back into the plug body until the locking tang is engaged. After assembling the plug halves, check the back side of the female half to be sure the tab has not backed out.
