SUZUKI

ROTARY ENGINE SERVICE BULLETIN

Bulletin No. RE-10
August 22, 1975
Date _____

SUBJECT: RE5 SPARK PLUG INSTALLATION

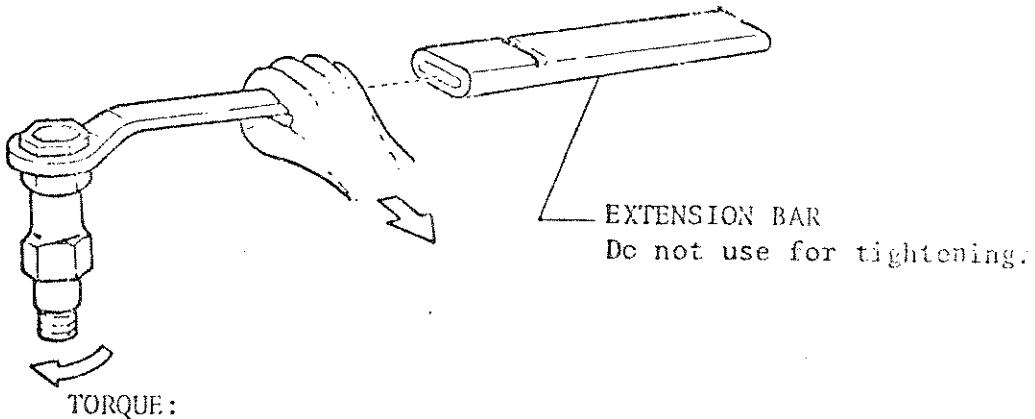
The RE5 spark plug is a taper seat design and does not require a gasket. Taper seat spark plugs require extra care when they are installed, to be sure they are not over tightened.

If the RE5 spark plug should be over tightened in the rotor housing, the copper inserts threads can be damaged or the insert may loosen and separate from the housing. Therefore, it is always recommended to use a torque wrench when tightening the spark plug.

TORQUE TO: 18 ft-lb

Always encourage RE5 owners to use a torque wrench when they install their own spark plugs. If a torque wrench is not available, advise the RE5 owner to use the spark plug wrench supplied in the tool kit without the extension bar. The spark plug can be torque adequately using this method.

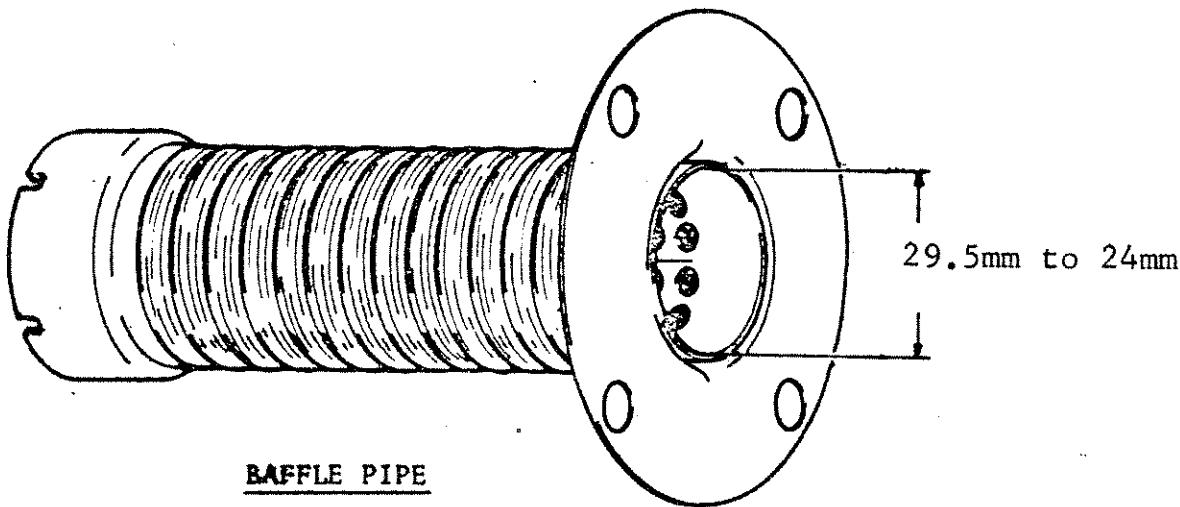
To reduce the RE5's exhaust noise level, the muffler baffles inner diameter has been decreased 5.5mm from 29.5mm to 24mm.

The new style baffles have been installed on and from Frame Number RE5-11901.
