**SUZUKI****Rotary**

Service Bulletin Index

U. S. SUZUKI TECHNICAL SERVICE

Bulletin No. RE-1
 Date DECEMBER 20, 1974
 Page 1 of 3

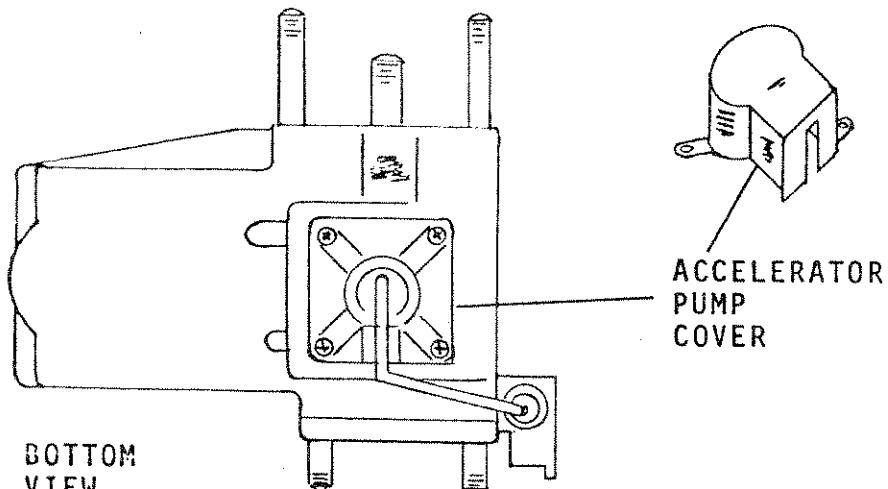
CARBURETOR: BOTTOM
VIEW

To prevent dirt from accumulating on the carburetor's accelerator pump, we will ship your dealership a protective cover for each unit you are invoiced for, prior to Engine Number RE5 - 11738. The protective cover should be installed using two of the phillips head screws mounting the accelerator pump to the bottom of carburetor.

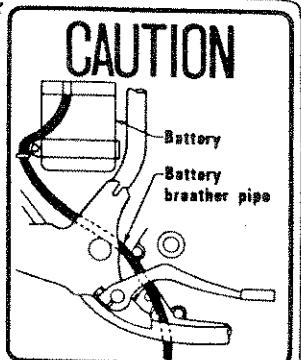
These items will be shipped to your dealership, if you are invoiced for an affected unit. The clamp should be installed on the voltage regulator's bottom mounting bolt. (The voltage regulator is located under the right frame cover and on the left side of the battery.)

The rubber vent tube should then be routed according to the diagram shown, which is also located on the rear fender, under the seat. This should be done prior to delivering an affected unit to a retail customer.

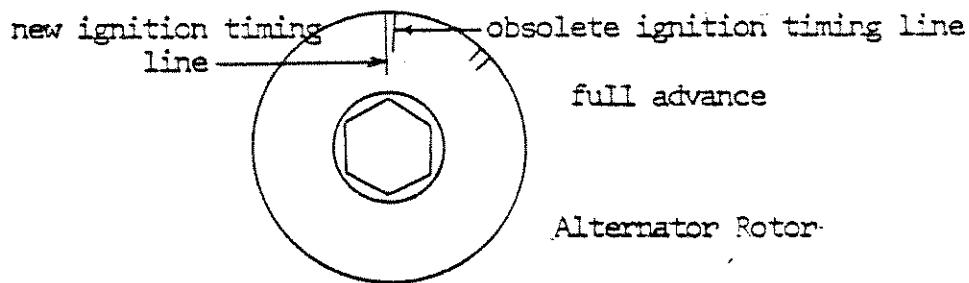
ADVANCE INDICATOR LINES

When checking the ignition timing advance, use the longest line shown in the illustration for setting the pointer wire to it referring to the idling ignition timing; the line next to it (obsolete line) will give 4 degrees difference from the specification.

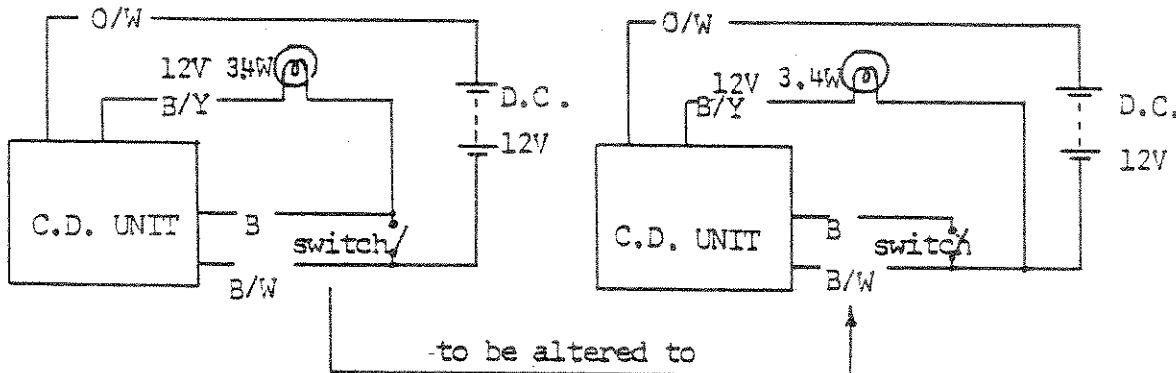
The existing check circuit in the manual can still be operable and the lamp lights as good as the altered circuit shown above. This operation, however, may damage the element inside the C.D. unit; whereas the altered one does no harm.

Please alter the illustration "Fig 8-4 C.D. Unit check circuit" in the page 76 as shown below.

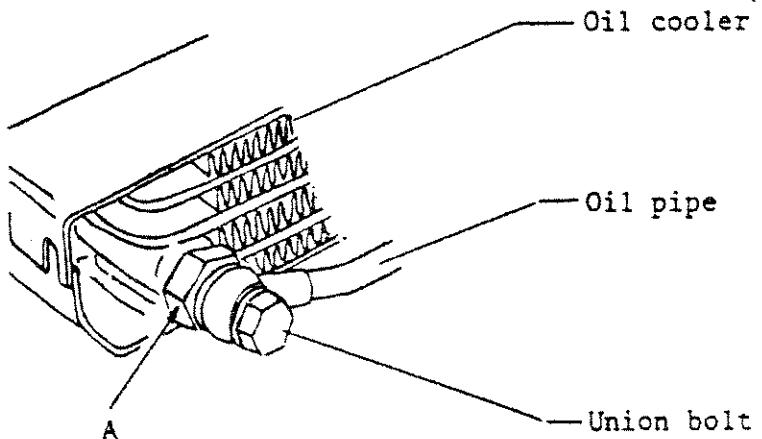
Please be sure to hold the indicated "A" securely with a wrench when tightening the union bolt. Tightening the union bolt with part "A" unrestrained applies undue stress to the oil cooler which may result in damage.

Damage of the oil cooler can also result in serious damage to the engine. Therefore, please follow the above instructions whenever tightening the oil pipe.

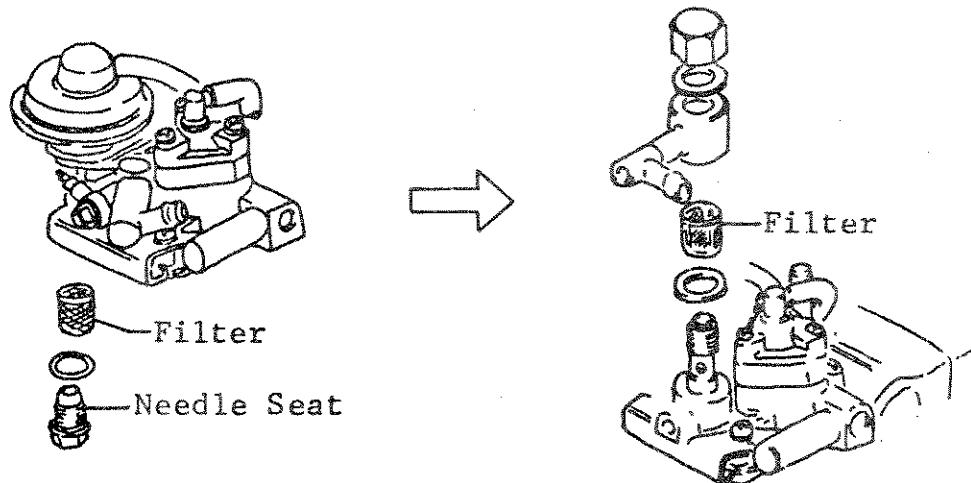
To service the carburetor fuel filter requires removal of the float chamber top and the needle seat.

The construction of the carburetor fuel inlet has been modified to provide easy access to the fuel filter.

This modification has been included from and including engine number RE5-13054.

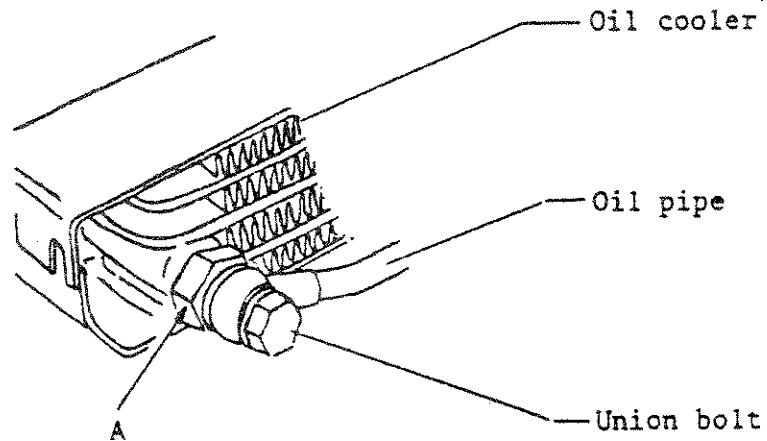
Please be sure to hold the indicated "A" securely with a wrench when tightening the union bolt. Tightening the union bolt with part "A" unrestrained applies undue stress to the oil cooler which may result in damage.

Damage of the oil cooler can also result in serious damage to the engine. Therefore, please follow the above instructions whenever tightening the oil pipe.
