**T****Service Bulletin  
Index****TWO STROKE**

# **Service Bulletin**

Subject: T500 TRANSMISSION REPAIR

Bulletin No: T-1  
Date: May 1, 1975

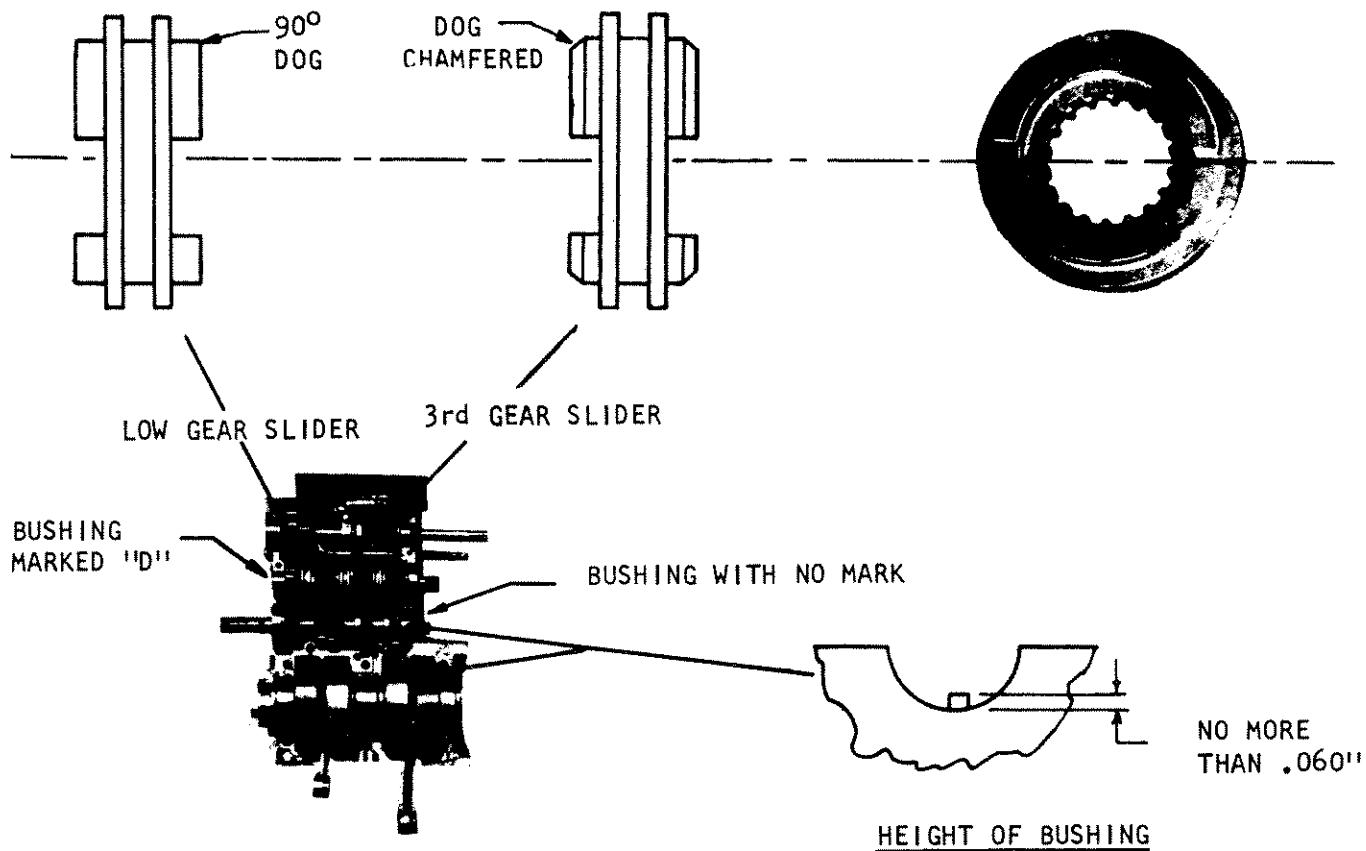
A. Do not interchange low gear slider wheel with 3rd gear slider wheel. If the transmission is assembled this way, the bike will jump out of first gear under any load. The difference between the two wheels is shown below:

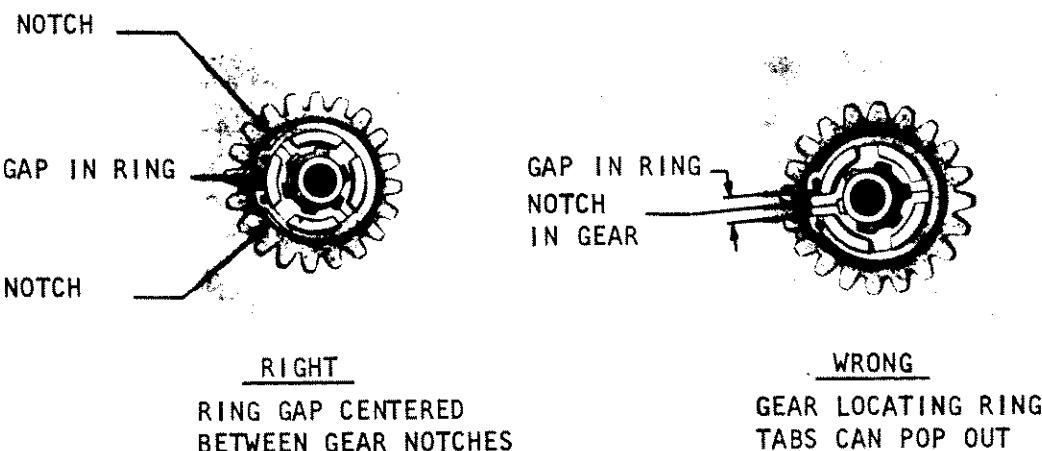
- C. Be absolutely sure that all bushings and bearings are properly located over the pins in the lower crankcase. We have had ruined crankcases from failure to follow this simple step. This is not a factory defect and we expect the servicing dealer to bear the expense of repair for this type of damage.
- D. Use new snap rings when assembling gear locating rings to transmission shaft.
- E. Locate the gap in the snap ring away from the notches in the gear. This keeps the snap ring from popping loose if the tabs move over. Be sure that the ends of the snap rings do not butt. If they do, cut off until there is at least a  $1/16"$  gap.

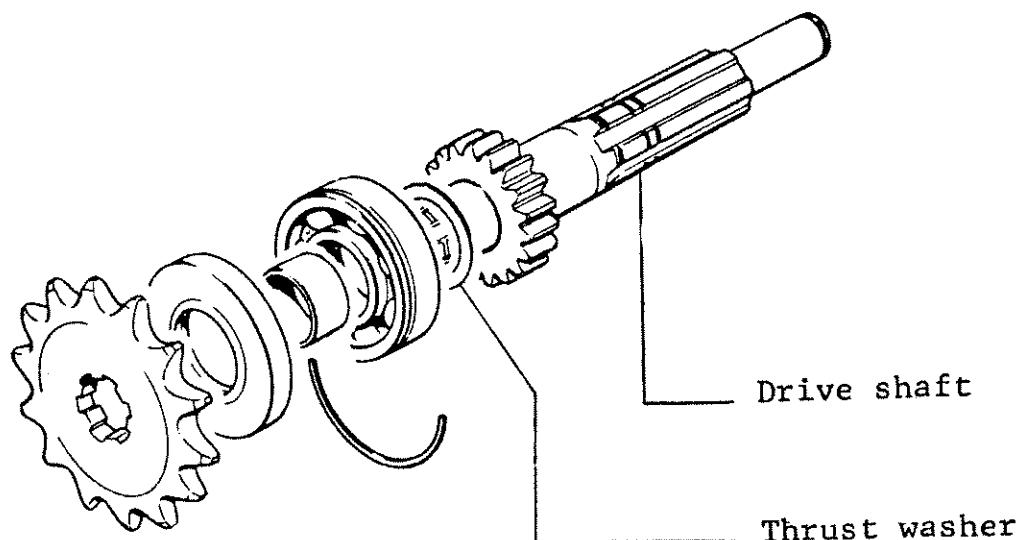
Top gear, driven, on the subject models has been increased in thickness and strength.

When using the new style driveshaft #24131-18002 with old style crankcases, the thrust washer #08211-22341 must be eliminated.

In the event that new cases are fitted and the old driveshaft re-used, washer #08211-22341 must be retained.

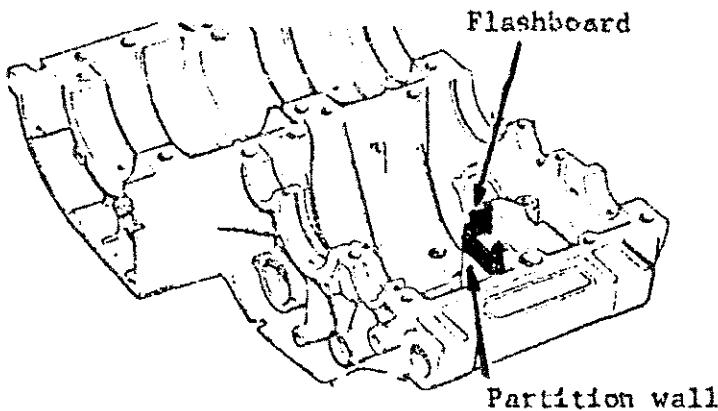
To effectively increase the durability of the T500 4th and 5th gears, the transmission oil capacity has been increased from 1200cc to 1400cc. The increased oil capacity has been applied to the T500 since the beginning of the 1974 "L" model production.

A rubber flashback applied to the primary oil transfer chamber in the lower crankcase half is used to accommodate the increased oil capacity. The flashback keeps the additional oil from entering the primary case, and therefore protects the clutch from excessive drag.

The flashback in position is illustrated below.

The rubber flashback is now available from the U. S. Suzuki Parts Department for T500's prior to the 1974 "L" model. Its application is strongly recommended whenever the crankcases are disassembled.

1. Clean the surface on which the flashboard is to be applied.
2. Apply a quick setting adhesive (such as Suzuki Thread Lock, etc.) on the mating surfaces of the flashboard and the chamber wall.
3. A metallic adhesive tape with 1400cc printed on it is supplied with the flashboard and should be placed over the embossed 1200cc on the upper crankcase half.
4. When the crankcases are re-assembled pour 1400cc of Suzuki Transmission Oil or a high quality 20W-40 motor oil.

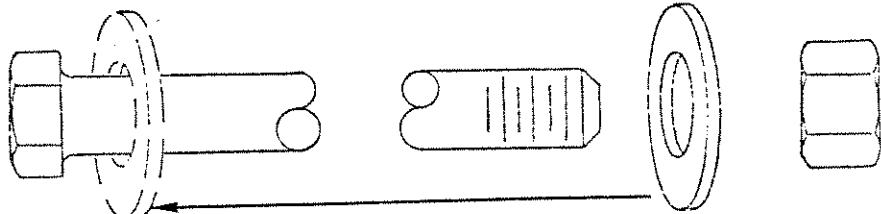
The shoulder radius of the T500 swing arm pivot shaft has been increased from 0.5mm to 1.0mm.

To accept the new type pivot shaft, the frame boss chamfer has also been increased 0.5mm.

**NOTE:** Should it be necessary to install a new type pivot shaft through an old type frame boss, simply move the washer from the nut side to the head side of the swing arm pivot shaft. The washer will conform to the shoulder radius of the pivot shaft.

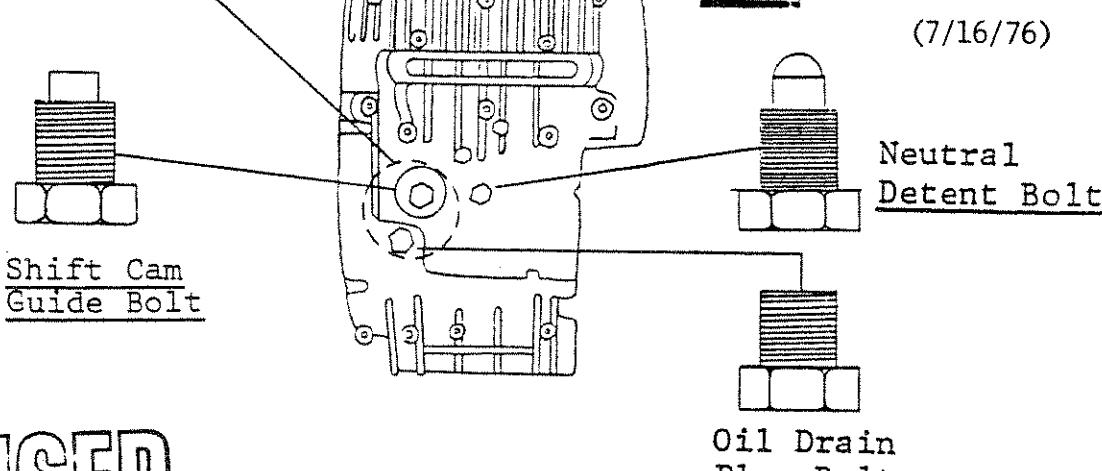
Bottom View of  
Lower Crankcase Half

We have received occasional reports of T500 transmission failure immediately after an engine or transmission overhaul. Upon disassembling and inspecting the transmission, two situations have been found. The first reason a transmission would fail was that an oil drain plug bolt from another model Suzuki (Example TS185/250) had been interchanged with the shift cam guide bolt during the overhaul. The second reason for the transmission failure was due to a magnetic oil drain plug that had been substituted instead of the shift cam guide bolt.

In both situations the bolt did not extend into the locating groove of the shift cam drum far enough to restrict the shift drum from sliding from side to side in the crankcases. When this happens the shifting forks slide with the shift cam, allowing two sets of gears to become engaged at the time. This results in severe damage to the gears, and requires their replacement.

Note: Remove both  
bolts to drain  
transmission  
oil.

Therefore, whenever a T500 is overhauled, or the transmission oil changed by your service department, the final inspection after reassembly should be the proper placement of the shift cam guide bolt.
