SERVICE BULLETIN

RADCO SALES LTD. - TECHNICAL SERVICE

Affected Models: DAY-TIME CHARGING PROBLEMS

Bulletin No.: 135

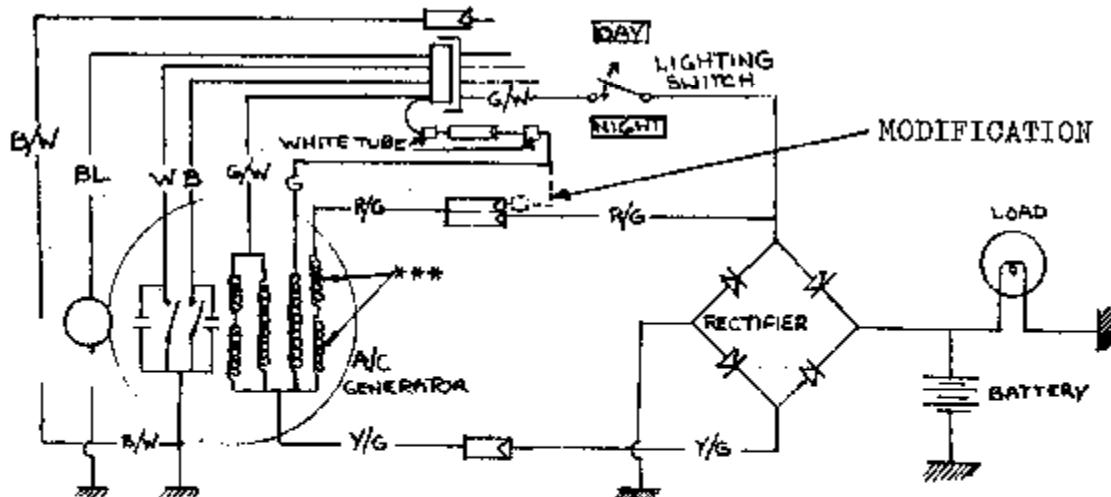
Insufficient charging rate during day-time riding.

The wiring diagram below is that of the AC generator assemblies under the part numbers 31400-18520 and 31400-18521.

As the diagram shows, the generator charges the battery with two coils connected in series when the ignition switch is in the day-time position. The two appropriate coils are marked (****) on the diagram.

The battery is charged by all the coils in the generator when the ignition switch is in the night-time position.

The charging capacity of the machine can be increased when the ignition switch is in the daytime position by disconnecting the white and green wires (These are connected on the diagram in the area where you see the words 'white tube') and connecting the removed male end of the green wire to the female coupler on the red/green wire.

As you can see, the charging rate in the night-time position remains unaffected as the extra coil brought into play by this modification is still utilized during night time riding.

This modification should only be performed when the customer complains of insufficient charging when riding during the day, and the rectifier and wiring and all component electrical ground circuits are in good condition.
