SERVICE BULLETIN	Bulletin No. 75-39 Date September 15, 1975 Page 1 of 3
SUBJECT: CLUTCH RATTLE ON TWIN CYLINDER MODELS		Read & Initial
Affected Models: ALL TWIN CYLINDER MODELS		Manager _____
Effective Engine No. _____		Parts _____
Reference: Page 44, T20 Service Manual		Service _____

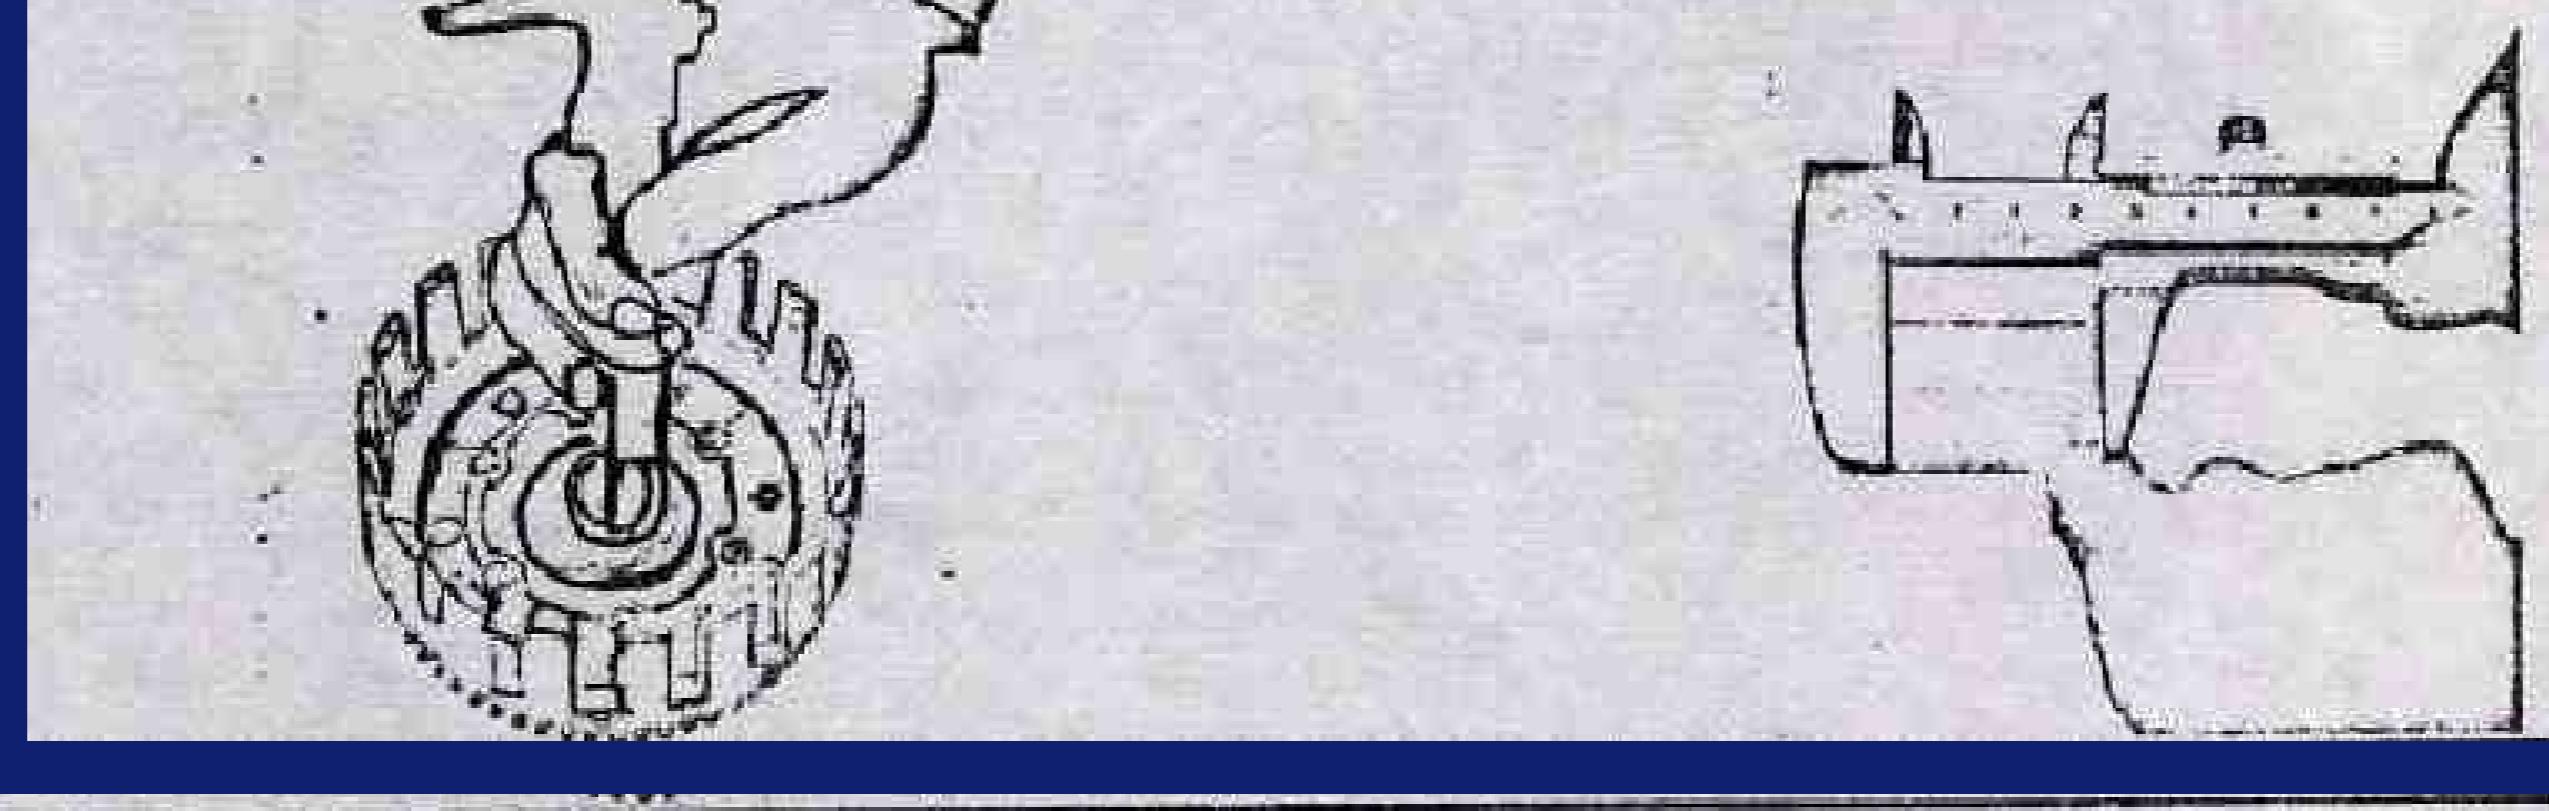
CAUSE: The usual cause of this problem is the clutch housing "walking" on the transmission countershaft. The housing has too much axial play because of normal wear on the thrust side of the clutch hub.

CORRECTION: Disassemble the clutch and measure the difference in length of the spacer and the thickness of the clutch housing. This difference is the amount of clearance that the clutch housing can slide back and forth on the shaft.

MODEL	AXIAL PLAY	
	MAXIMUM	MINIMUM
X6, TC250, T200, TC200, T250, T350, T305, TC305	.007 inch	.003 inch
S32	.008 inch	.004 inch
T10	.006 inch	.004 inch
T500	.007 inch	.002 inch

If the measurement is more than the maximum, rub one end of the clutch spacer on a honing stone until the difference is near the minimum above. Don't overdo it, or the clutch will not release.

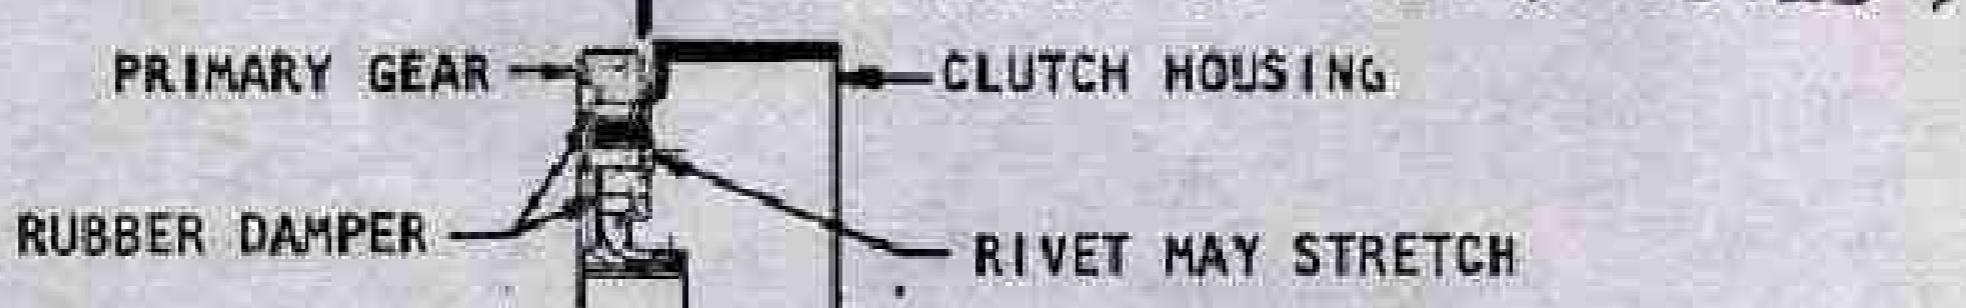
A. The clutch housing/primary gear is a riveted assembly. There are rubber dampers which cushion the drive shock between these two parts. If the rivets stretch or the dampers soften, the clutch housing will wobble and make the same noise. Try to separate the two parts with your hands.

There should be less than 1/32 inch play between the two parts. Don't try to tighten the rivets. Instead, replace the assembly.

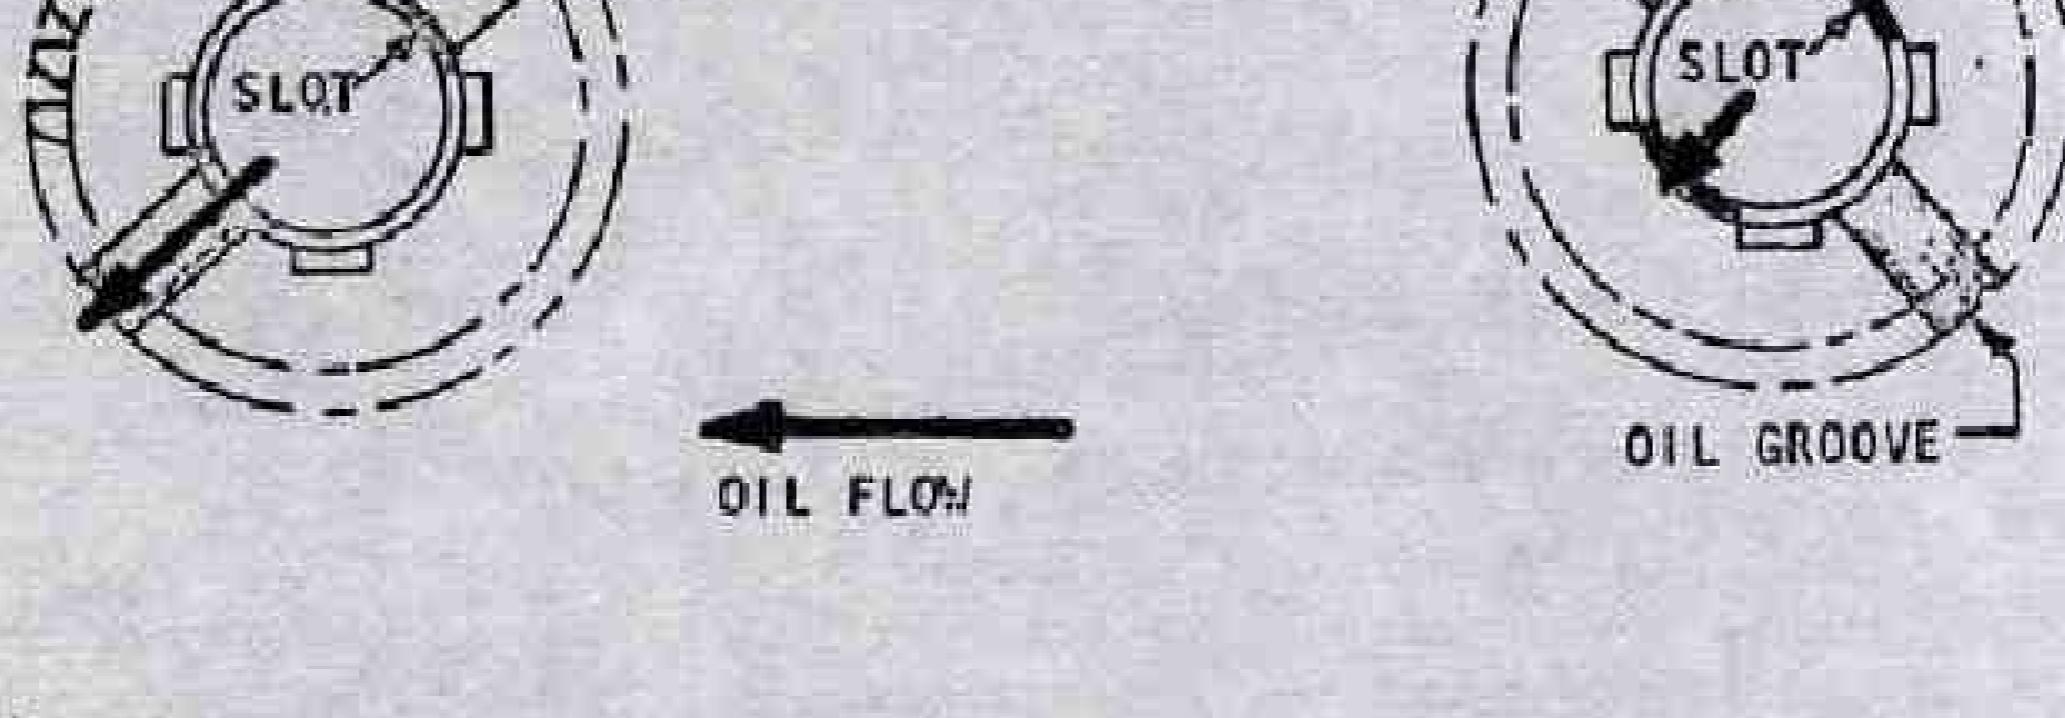
C. The X6, TC250, T200, TC200, T250, T305, TC305, T350, clutch housing is fitted with the kickstart drive gear on its backside. Be sure that the oil grooves in the gear are matched with the slots in the clutch bearing sleeve. Otherwise, the thrust face of the housing will prematurely wear due to lack of oil.

RIGHT
Slots Lined Up

WRONG
Gear Installed 90° off on Splines

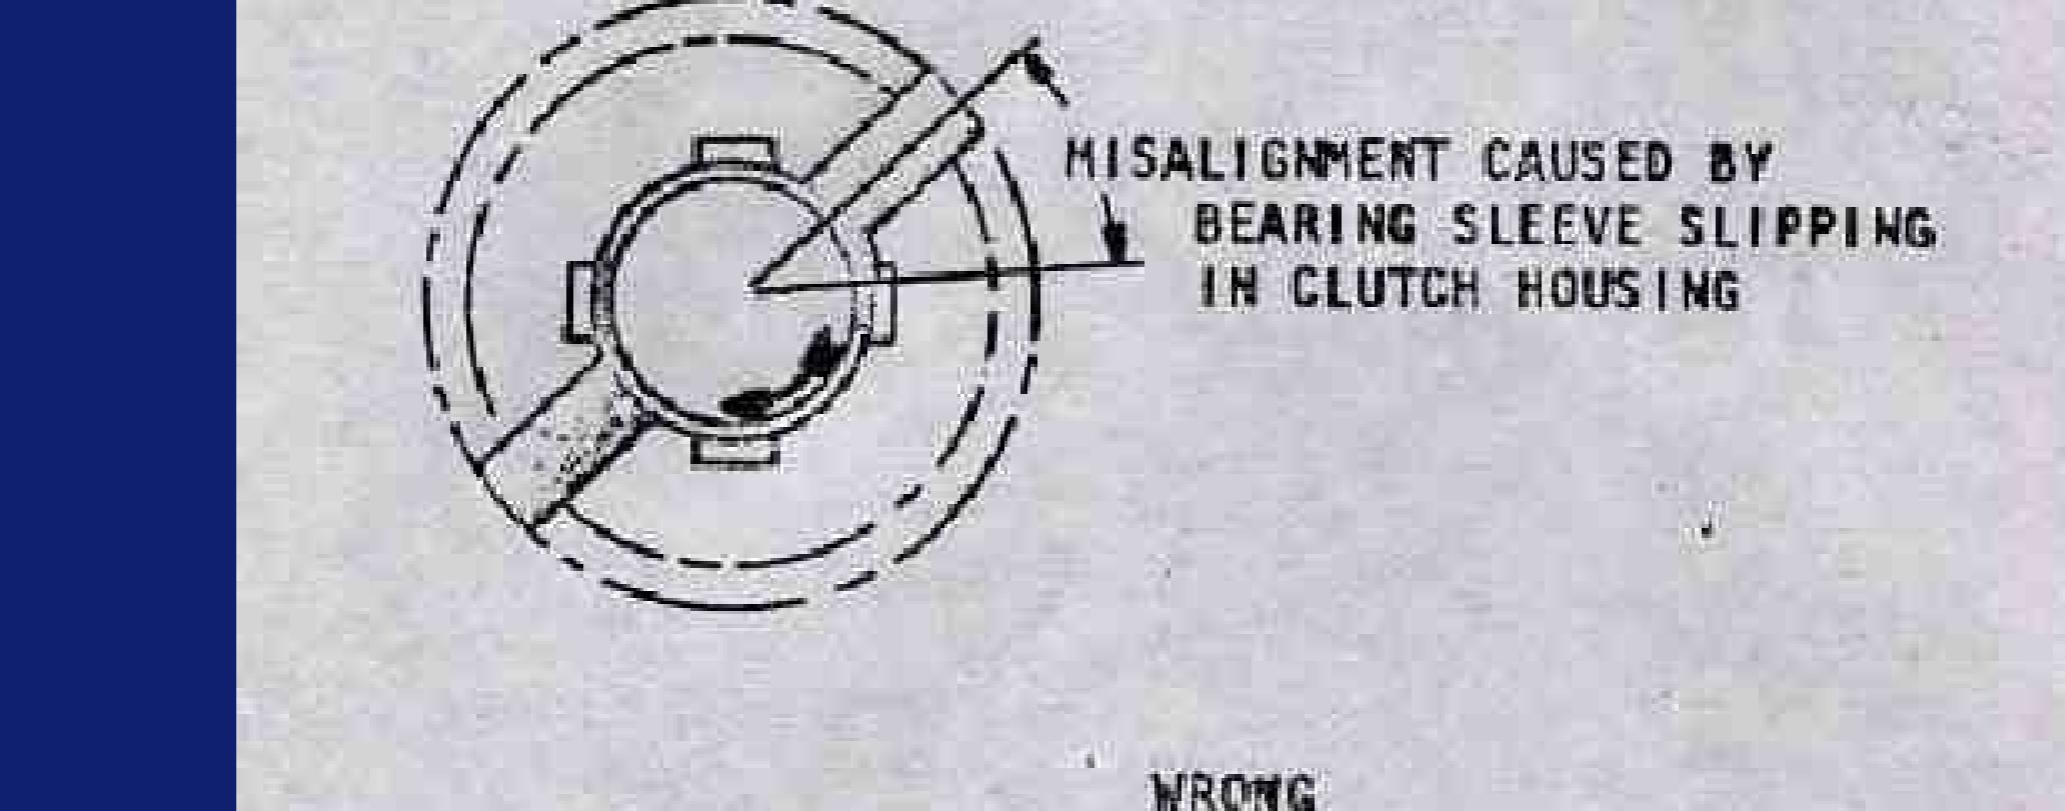
WRONG
Bearing has seized on shaft, causing sleeve to slip in housing.

D. If the transmission oil level is too low, or if extreme heat is present in the clutch assembly, the clutch housing bearing will seize on the transmission driveshaft. The engine will stop suddenly, and the inertia of the rolling motorcycle will cause the clutch bearing sleeve, which is pressed into the housing, to spin in the housing. After it frees up, the clutch will work well. However, the thrust surface of the clutch housing will starve for oil and wear too quickly, again causing this "rattling" noise.
