**SUZUKI**

Service Bulletin

Bulletin No: GT-34
Date: Mar. 26, 1976

Service APPSubject: GT500 SHIFTING CAM GUIDE BOLT LOCATION
REFERENCE: Service Bulletin #T-5NOTICE:

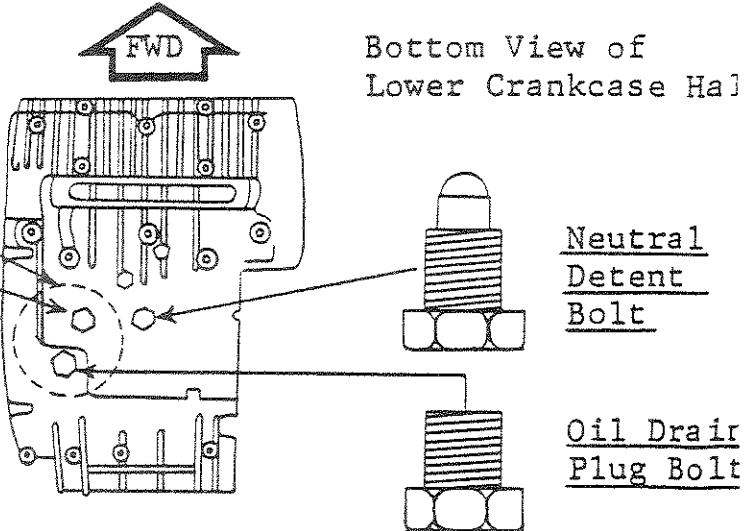
Bottom View of Lower Crankcase Hal

We have received occasional reports of GT500 transmission failure immediately after an engine or transmission overhaul. Upon disassembling and inspecting the transmission, it was found that the transmission oil drain plug and the shift cam guide bolt had been mistakenly interchanged during the overhaul.

Shift Cam Guide Bolt**UPDATED**

The shift cam guide bolt restricts the shift cam drum from sliding from side to side inside the crankcase assembly. When these two bolts are interchanged, the oil drain plug does not extend into the locating groove of the shift cam drum, allowing the drum to slide from side to side. When this happens the shifting forks slide with the shift cam, allowing two sets of gears to become engaged at the same time. This results in severe damage to the gears, and requires their replacement.

NOTE: Remove both bolts to drain oil. After draining oil make sure of correct placement of both bolts.

Therefore, whenever a GT500 is overhauled, or the transmission oil changed by your service department the final inspection after reassembly should be the proper placement of the shift cam guide bolt and oil drain plug.
