**SUZUKI**

# Service Bulletin

Subject: RM250/370 GENERAL MAINTENANCE

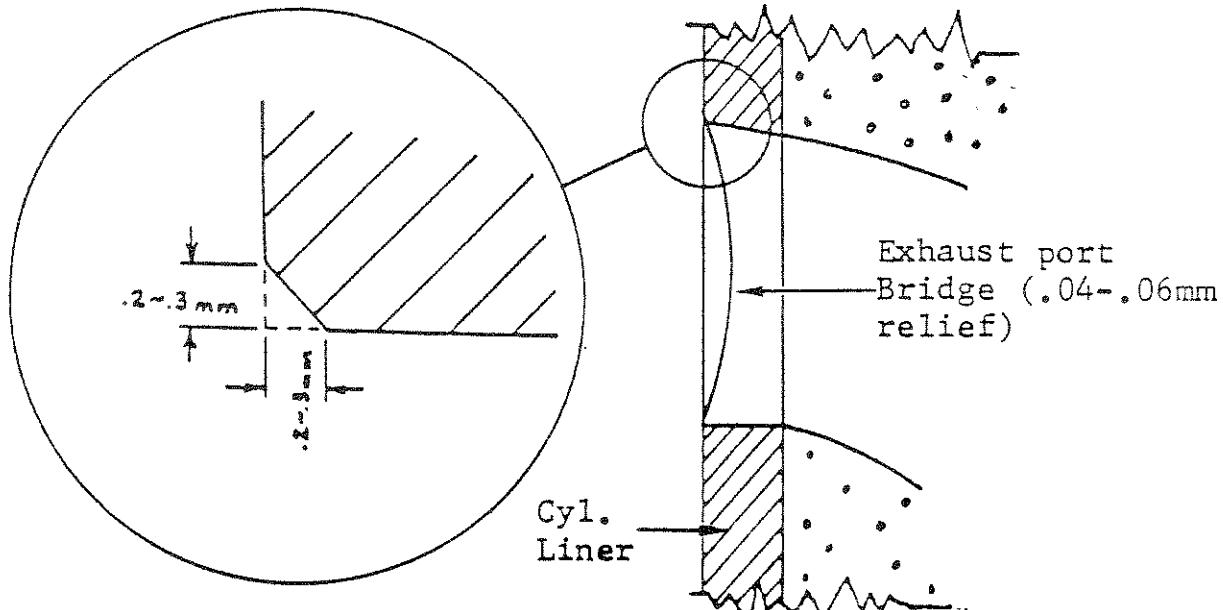
## CYLINDER PORT CHAMFER:

Whenever inspecting an RM250 or RM370's cylinder port chamfer, you will notice that the chamfer is very slight as compared to other Suzuki models. Both the vertical and horizontal dimensions of the chamfer should be  $.2\text{-.3mm}$ , as shown below:

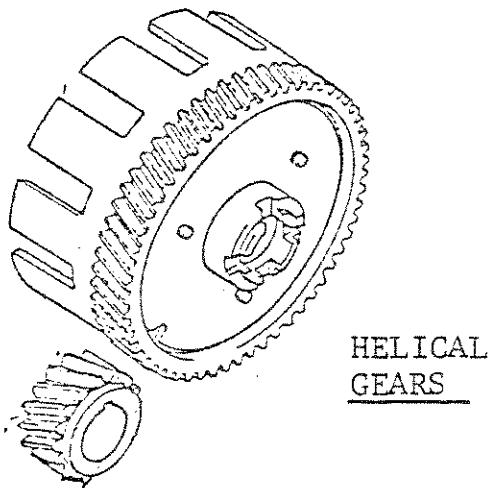
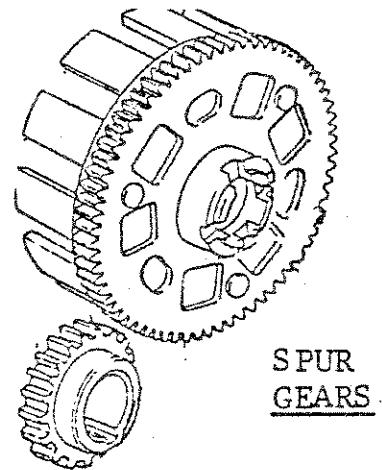
The mechanical efficiency of the RM100's primary drive and driven gears has been increased. This has been accomplished by changing the design of the helical type gears to spur type gears (commonly referred to as straight cut gears).

Spur type primary drive and driven gears are installed on RM100's on and after the following Engine Number: RM100-11445.

Due to the major change in design, the individual gears are not interchangeable separately. However, they are interchangeable when both drive and driven gears are changed as a set.

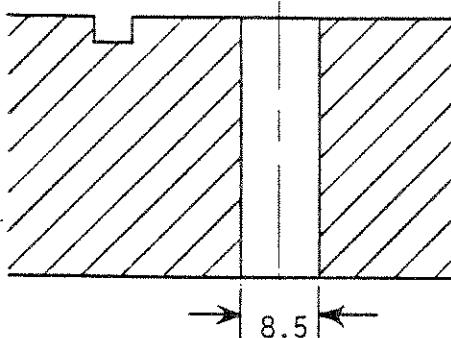
(Part Number 11300-41811)

A. RM250's having Frame Numbers RM250-10001 through 12172 do not have engine mount bushings installed. The dimensions of the engine bolt mounting holes are illustrated below.

All measurements are  
in millimeters

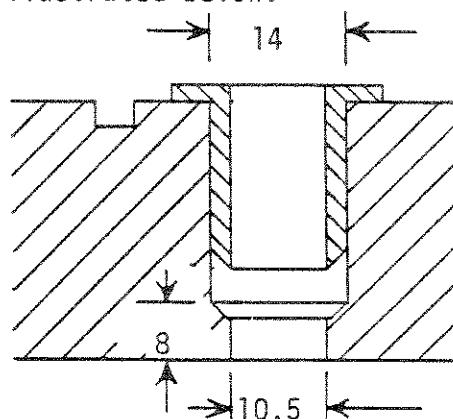
(Part Number 11300-41813)

C. As of Frame Number RM250-13751 and after, the upper rear engine mounting bolt's size was changed to 10mm. The size of the bushing was also increased to accept the new bolt as illustrated below.

The frame was also modified to accept the larger diameter bolt.

NOTE: The RM250 has had a bushing added to the upper rear engine crankcase mount only.

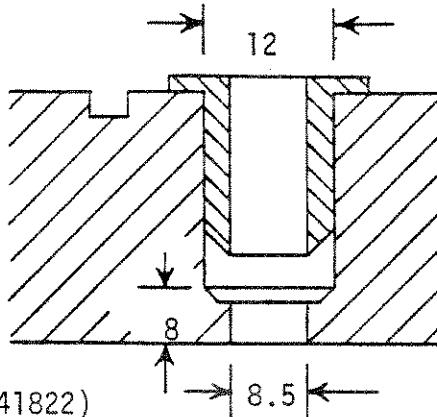
A. RM370's from initial production through Frame Number 13708, had both an upper and lower rear engine mount bushing installed. They are illustrated below.

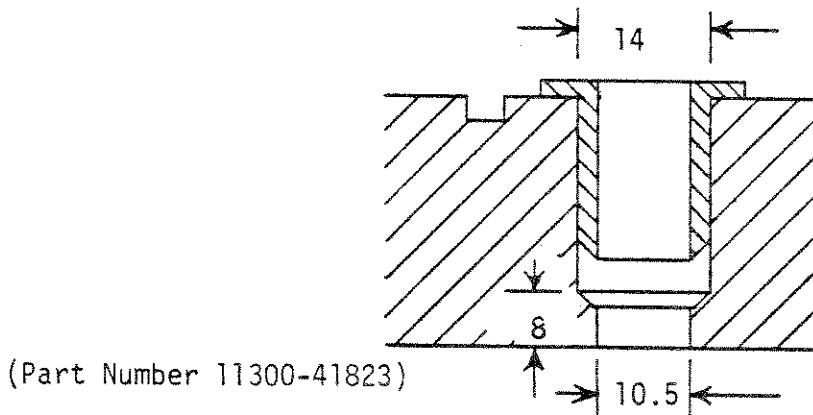
B. As of Frame Number RM370-13109 the upper rear engine mount bolt's size was increased from 8mm to 10mm. The inside diameter of the upper rear engine mount bushing was increased to accept the larger engine mount bolt.

NOTE: This change was for the upper rear mount only.

The frame was also modified to accept the larger diameter bolt.

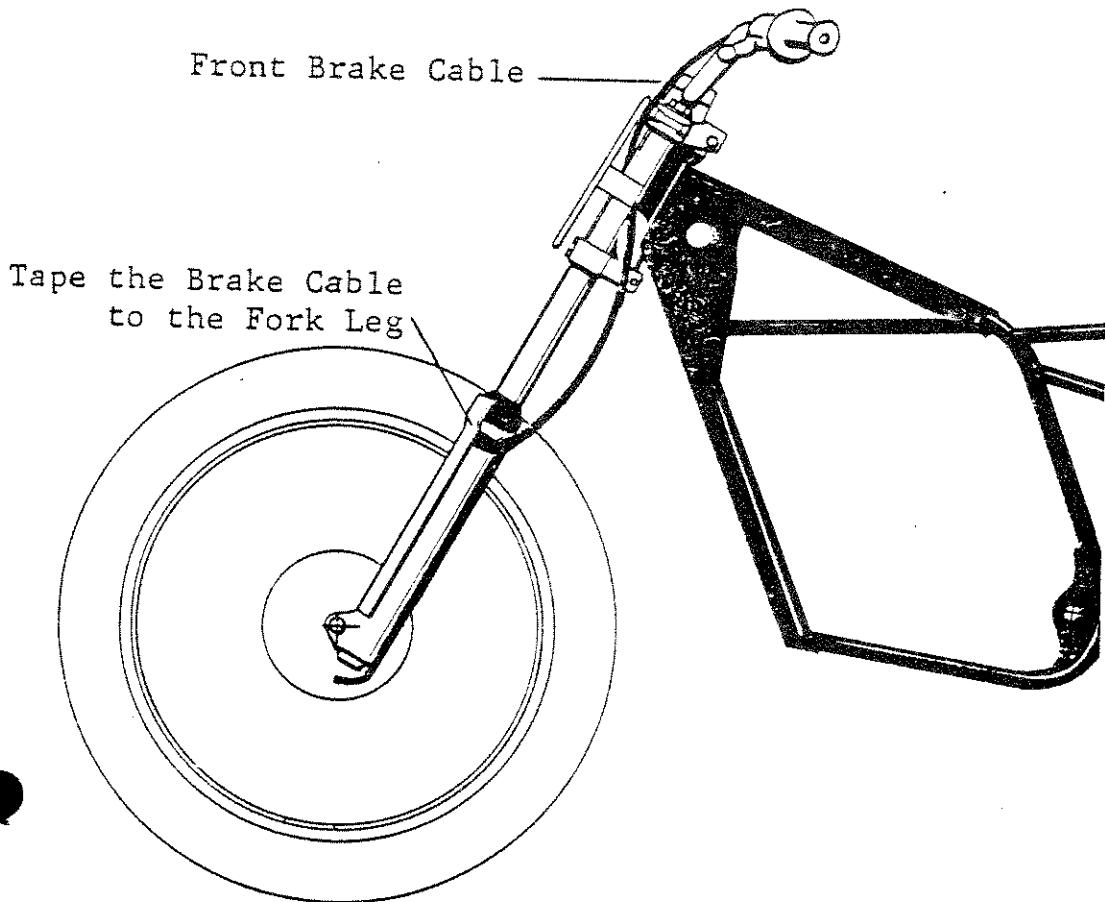
Reports have been received indicating incorrect placement of the front brake cable on the RM100. When the cable is routed in front of the front number plate, there is the possibility of the cable hanging up on the upper left fork tube securing bolt when the forks are fully compressed. If the front brake cable is adjusted tighter than normal for off road riding, the brakes can become locked.

To eliminate the possibility of this happening, be sure the front brake cable is routed behind the front number plate, and that it exits through the rear side of the steering stem. Also, be sure that the cable is taped to the lower fork leg just below the dust seal.

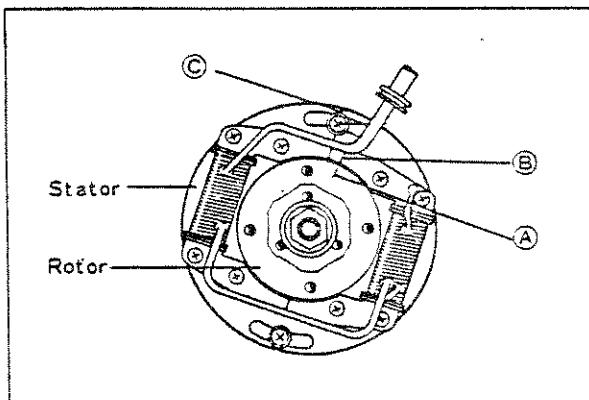
1. Remove the spark plug and install the Timing Guage (09931-00112). Position the piston at T.D.C. and adjust the Timing Guage to "0".
2. Turn the rotor clockwise until the Timing Guage indicates 0.31mm BTDC. Hold the piston in that position.

3. Adjust the stator so that line (A) aligns with rotor line (B). Next tighten the 2 stator base plate screws. This establishes the ignition timing as specified for the 1976 RM125A engine.

1. Loosen the two stator base plate screws.
2. Position the timing mark (C) to the center of the securing screws. This method approximates the ignition timing for this model.

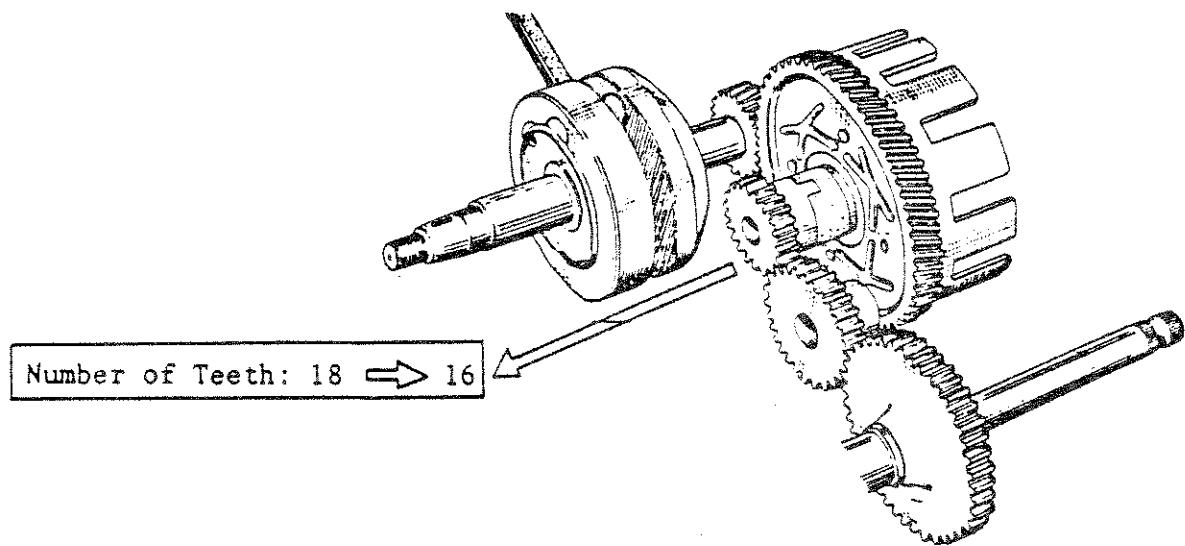
To further increase durability of the RM125 kick starter driven gear, the number of teeth on the gear has been decreased from 18 to 16.

The old and new style parts are interchangeable. It is recommended however that when the old style part needs replacement that the new style part be used.
