SUZUKI
2-Stroke
Service Bulletin
Index

Bulletin No: GT-1
Date: May 1, 1975

Subject GT750 COOLING SYSTEM

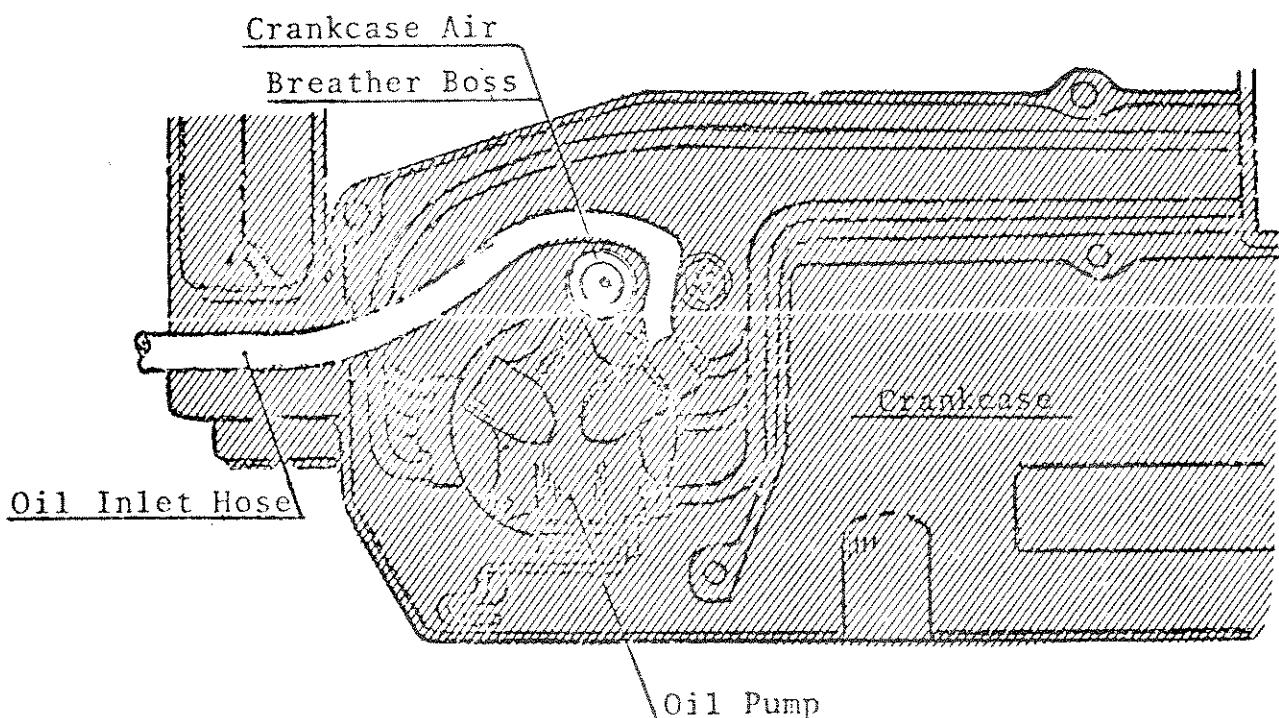
If care is not taken it is possible to pinch the inlet line from the oil tank to the oil pump when installing the oil pump cover. Pinching this line closed will result in no oil getting to the oil pump, or to the engine. Naturally this can cause a multitude of problems due to lack of lubrication.

1. Take special care that the oil pump inlet hose is routed around the crankcase air breather boss before installing the oil pump cover.
2. Before tightening down the screws holding the cover, check that the cover seats flush against the crankcase, without any gaps. If there is a gap, this would indicate that the hose might be pinched between the breather boss and the cover.
3. After tightening the screws, start the engine and check at the lines for any evidence of oil starving.

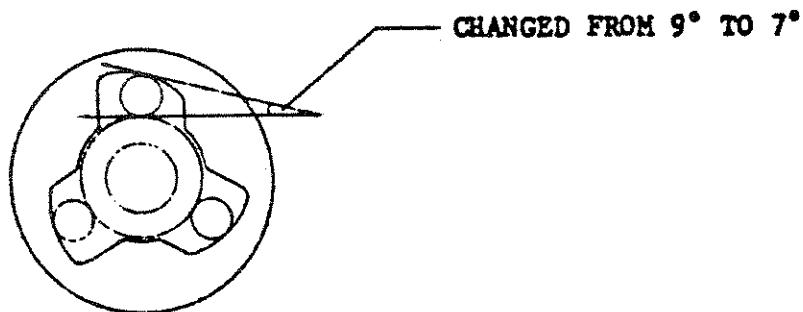
1. STARTER CLUTCH HOUSING

Reports have been received of starter clutch failures on the subject models. While the symptoms are similar, there have been various contributory factors involved. Therefore, several modifications have been made to effect a total cure, as the following illustrations show.

The wedge has been altered as shown in the illustration.

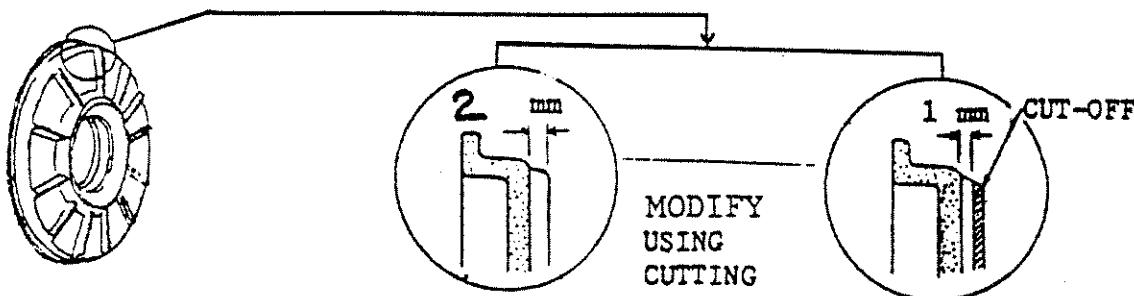
On future parts orders only the new type starter clutch parts will be supplied. However, the old type LH crankshaft oil seal will still be supplied until such time as the existing stock is exhausted. Therefore, when the old oil seal is retained in the unit and the starter clutch is modified or replaced, it is necessary to check the rib height of the oil seal and modify the same as shown.

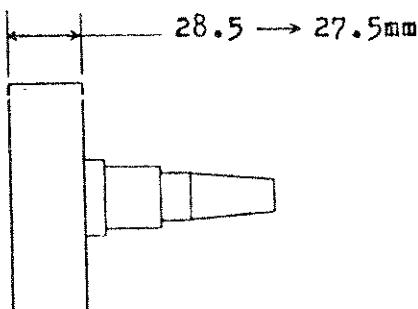
A) Crank Wheels:

The width of the crank wheels has been reduced from 28.5mm to 27.5mm.

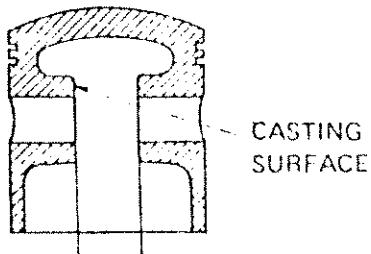
EARLY TYPE

The pistons inside surface has been changed from a casting surface to that of a machined surface. The inside dimension between the wrist pin bosses has also been changed.

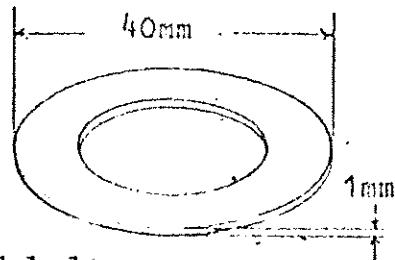
D.) **Thrust washer, crank pin bearing:**
In order to have the connecting rod floating on the crank pin, this thrust washer has been modified as shown below.

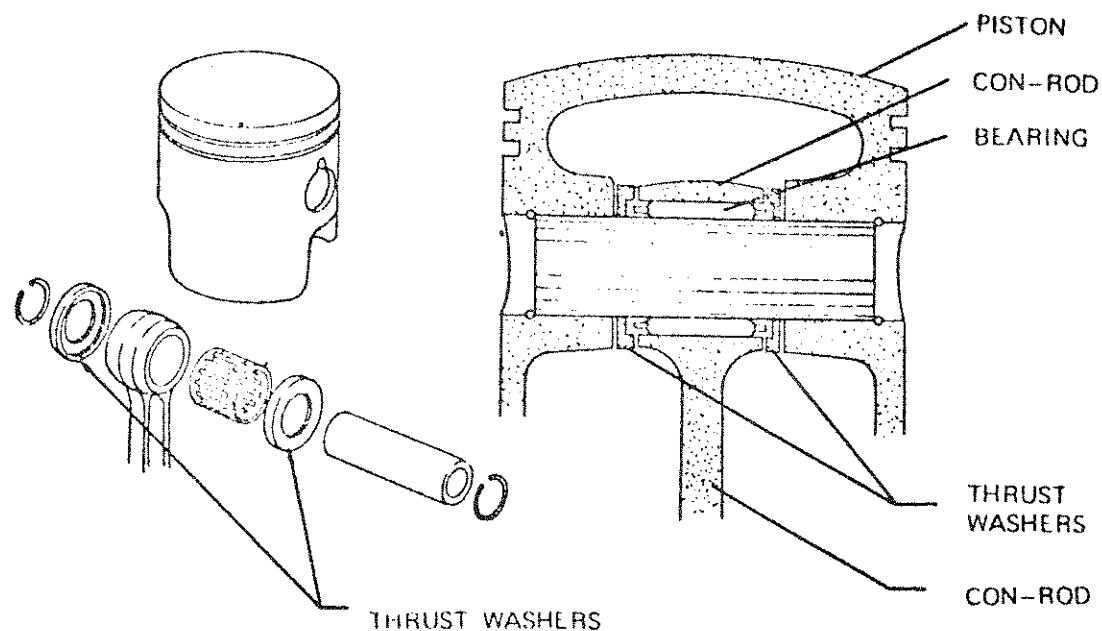
NOTE: Two different pistons are used in the GT750 engine, and they are marked "R" and "L" on top of the piston crown. The "R" piston is for the right cylinder and the "L" pistons are for the left and middle cylinders.

- 1) The pistons and thrust washers should be assembled as shown below.

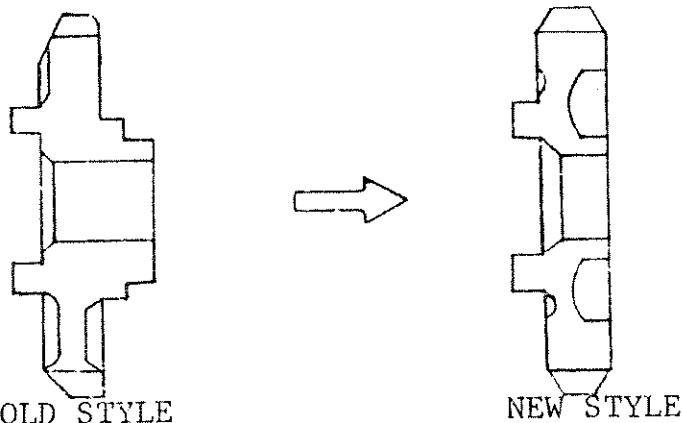
The GT380 kick starter drive gear has been increased in strength. Its shape also has been changed as shown below.

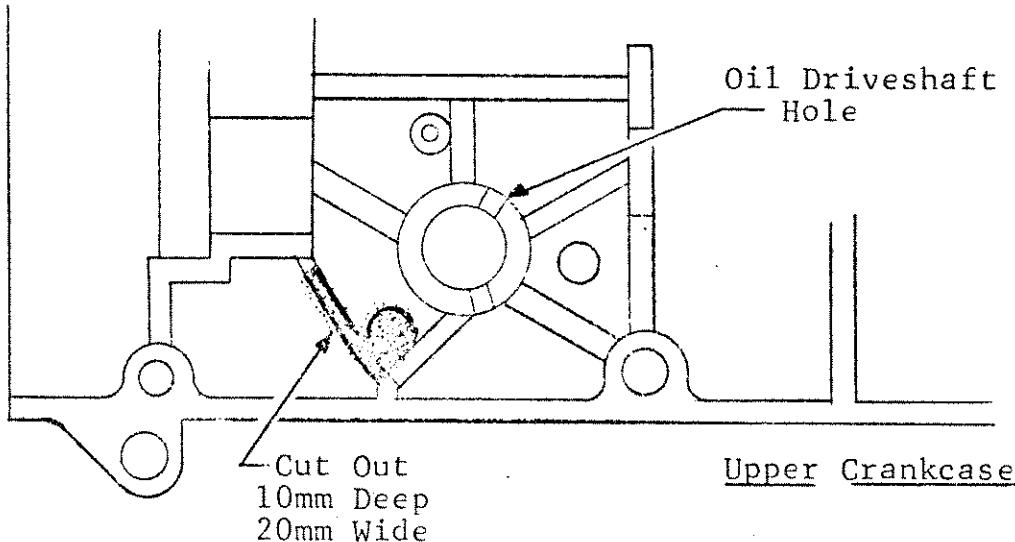
To increase the transmission oil capacity of GT380's prior to the 1974 "L" model to 1500cc, a rubber flashback must be applied to the primary oil transfer chamber located near the right rear of the lower crankcase half. The flashback is now available from U. S. Suzuki's Parts Department and its use is strongly recommended whenever the crankcases are disassembled.

1. Clean the surface on which the flashboard is to be applied.
2. Apply a quick setting adhesive (such as Suzuki Thread Lock, Loctite, etc.) on the mating surfaces of the flashboard and the chamber wall.
3. To assure that oil reaches the primary case you must cut the adjacent rib of the upper crankcase as illustrated below.

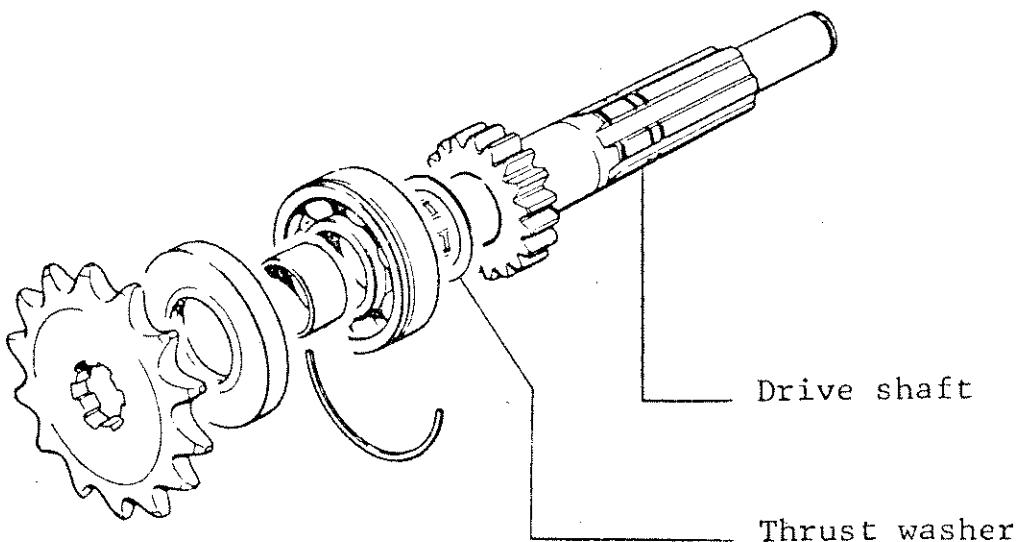
Top gear, driven, on the subject models has been increased in thickness and strength.

When using the new style driveshaft #24131-18002 with old style crankcases, the thrust washer #08211-22341 must be eliminated.

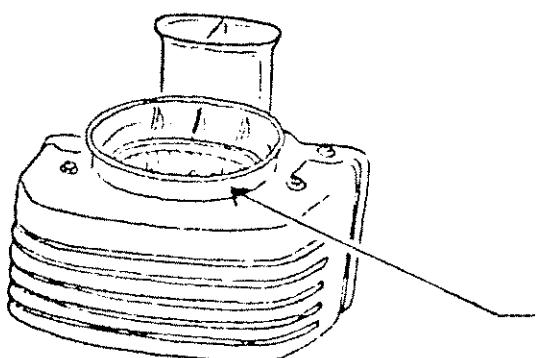
1. OLD TYPE

DO NOT APPLY SUZUKI BOND NO. 4
ON AIR INLET HOSE, OTHERWISE
IT MAY CAUSE CLOGGING OF THE
CARBURETOR.

COAT WITH "SUZUKI BOND NO. 4"
ALL AROUND.

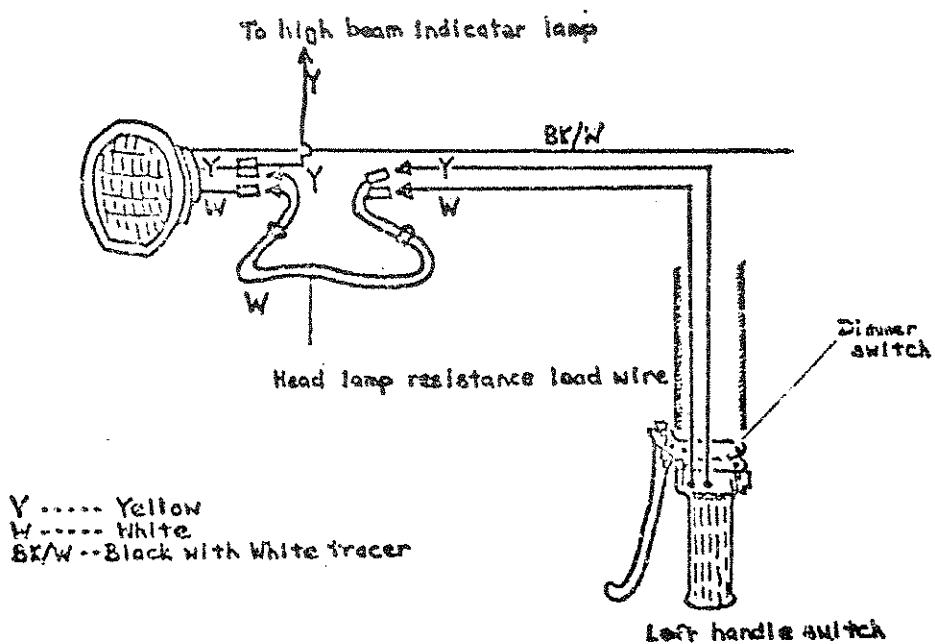
GT250

Routine reports indicate that certain units of the subject models have experienced premature headlight bulb failure. The usual cause is excessive voltage combined with high r.p.m. vibrations.

Should the condition still exist, install the resistance lead wires, according to the following instructions.

Disconnect the white and yellow wire couplers inside the headlight shell. Install the resistance leads, in series, as shown in the illustration.

The resistance leads are available from U. S. Suzuki's Parts department. The part number is 37131-18999.

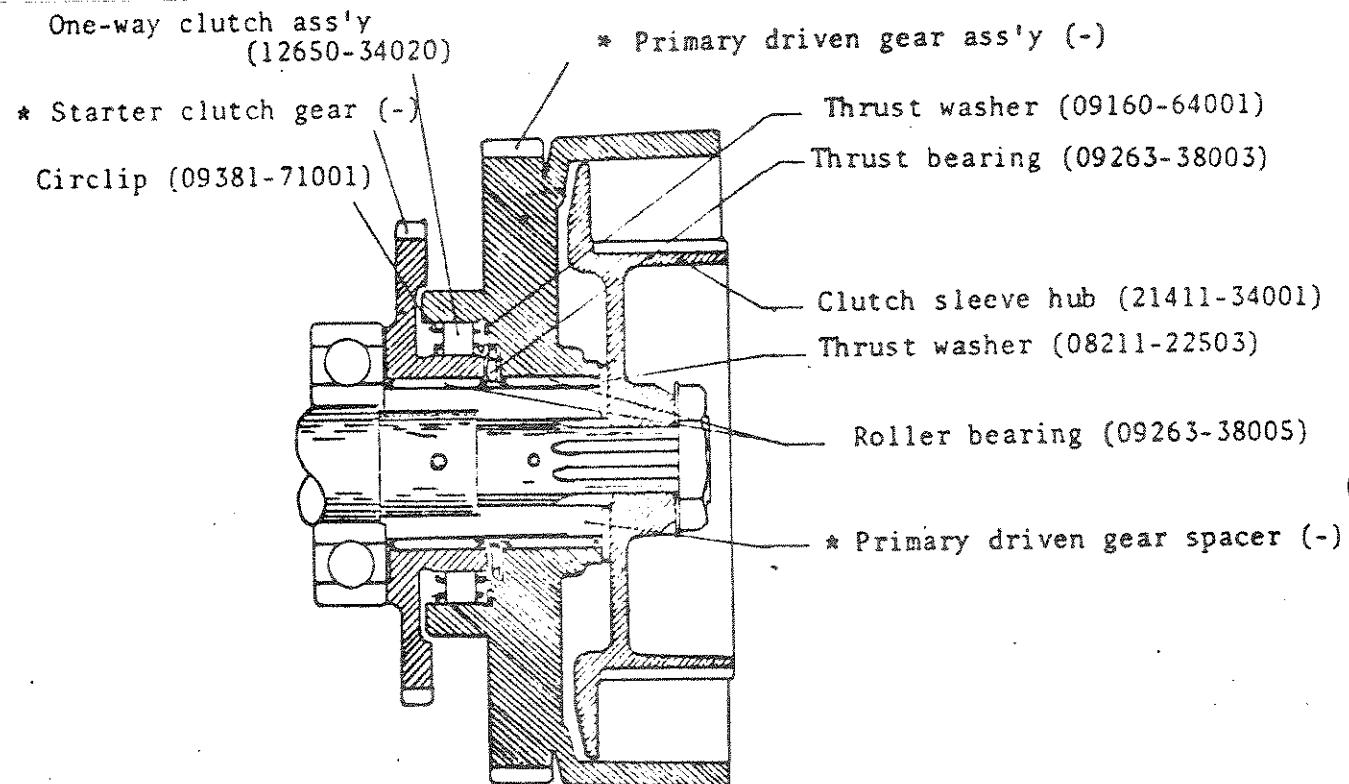
IV. Below is a sectional illustration of the starter clutch assembled and installed.

1. Since the clutch sleeve hub thrust washer (08211-22503) is not included with the starter clutch assembly, be certain that it is installed. This washer is used in both new and old style clutches.
2. The starter one-way clutch is susceptible to foreign particles in the transmission oil. Therefore, transmission oil changes at regular intervals of 2,000 miles are strongly recommended. At the same time, the transmission should be flushed with cleaning solvent.

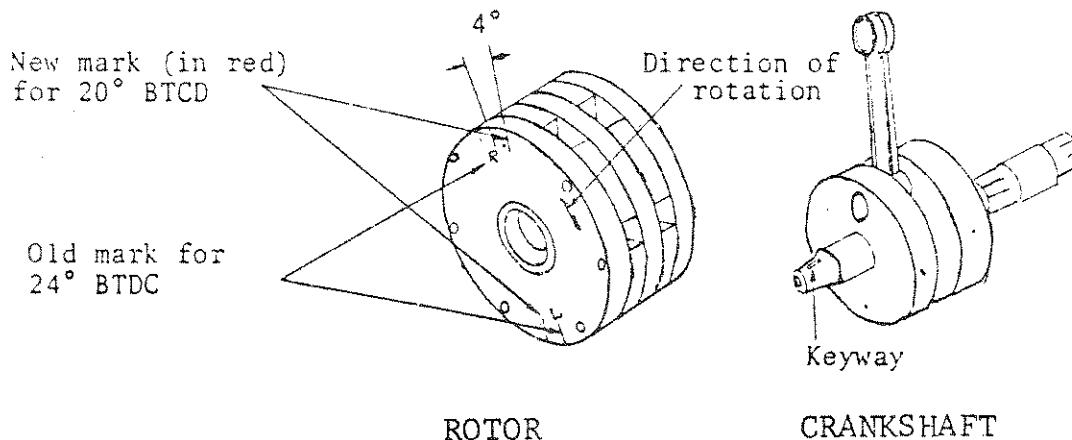
In conjunction with other engine design changes, the ignition timing for the 1976 GT250 has been retarded 4° from the 1975 specification of 24° (2.88mm) to 20° (2.05mm).

In order to have the timing marks on the rotor align with the stationary mark on the crankcase, it is intended to relocate the crankshaft's rotor keyway. However, some initial 1976 production units are equipped with crankshafts without the keyway being relocated. Therefore, another timing mark has been stamped on the rotor and is distinguished by red paint.

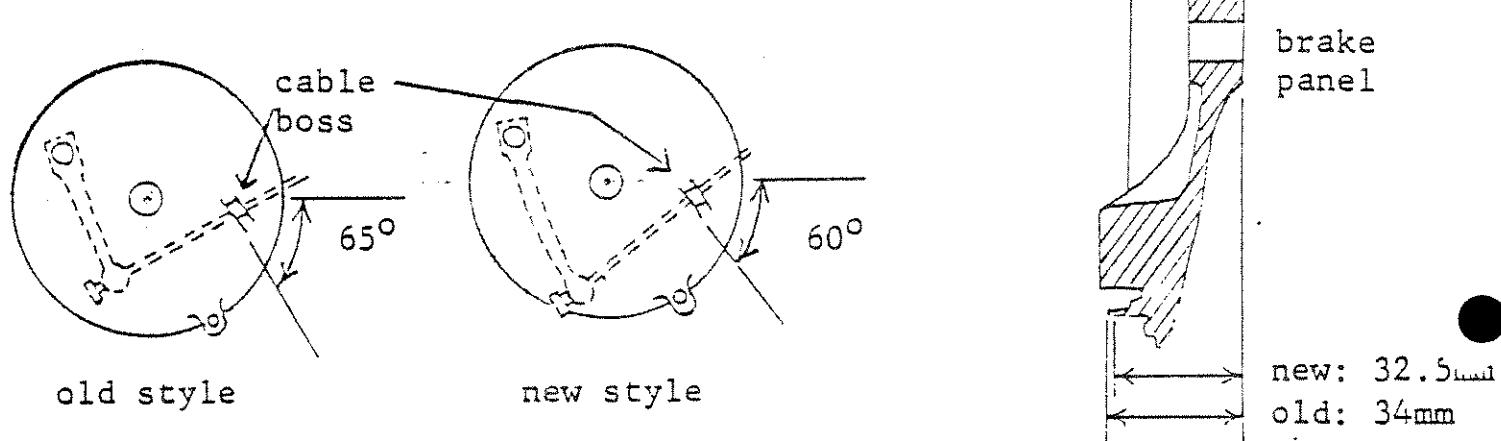
IV. Rear Brake Panel

In compliance with changes I, II, III, the rear brake panel (brake backing plate) has undergone two changes: the first change is the angle of the cable boss in conjunction with the increased length of the cam lever. Secondly, at the same time the width of the panel has been decreased 1.5mm, as shown.

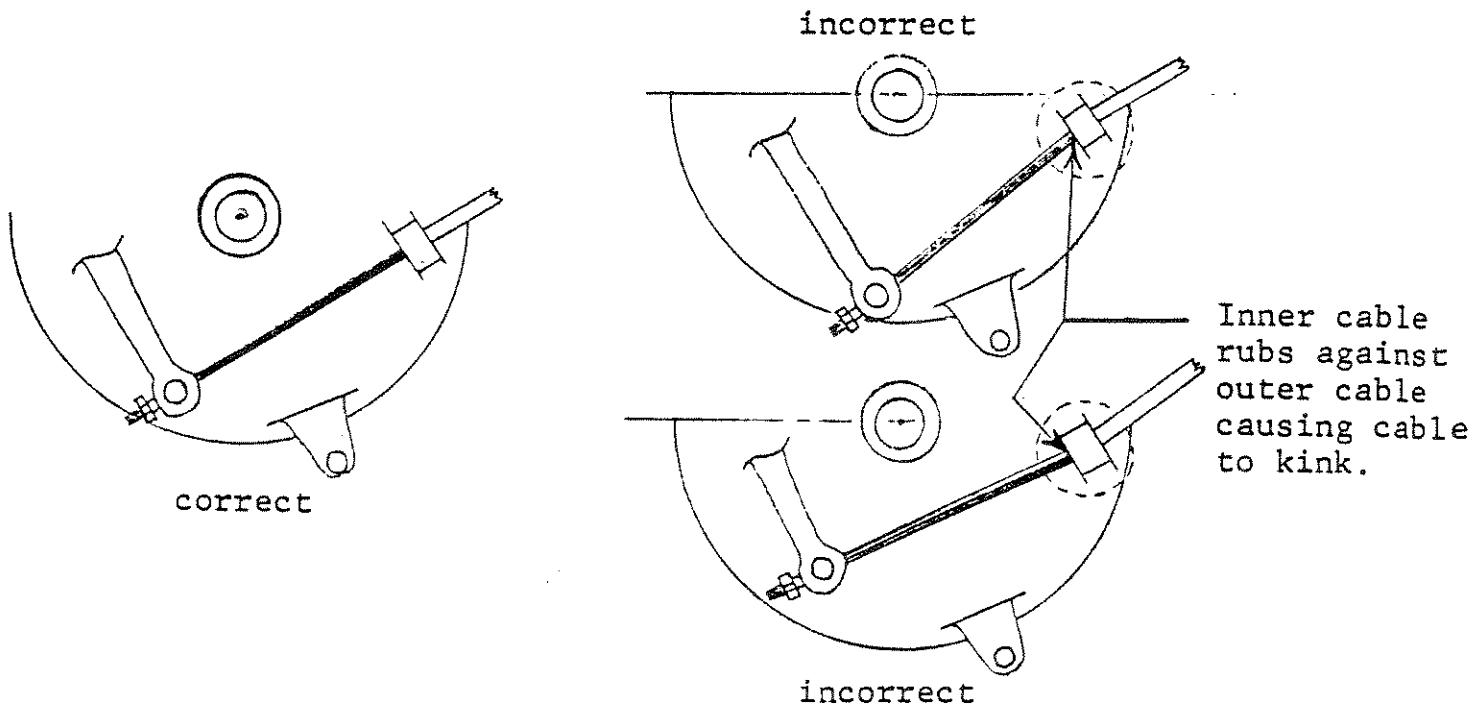
1. Be sure to use the OLD brake shoe (28mm wide) if the brake panel is the older style. The new style shoes mounted on the old style brake panel will not have the proper side clearance.
2. Damage to the brake cable will occur if the incorrect brake cam lever is used with either brake panel. This is due to the lengths of the cam levers and corresponding angle of the brake panel cable boss. This is illustrated below.

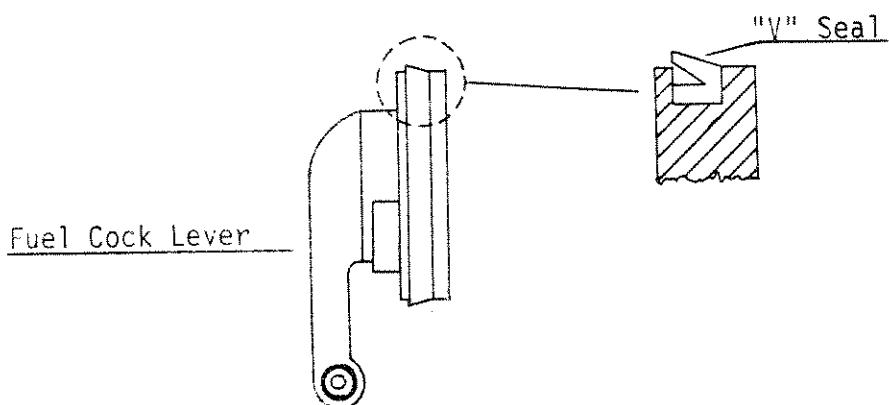
To prevent fuel cock seepage, a "V" seal has been installed around the fuel cock lever, to seal the lever to the fuel cock body, as illustrated below.

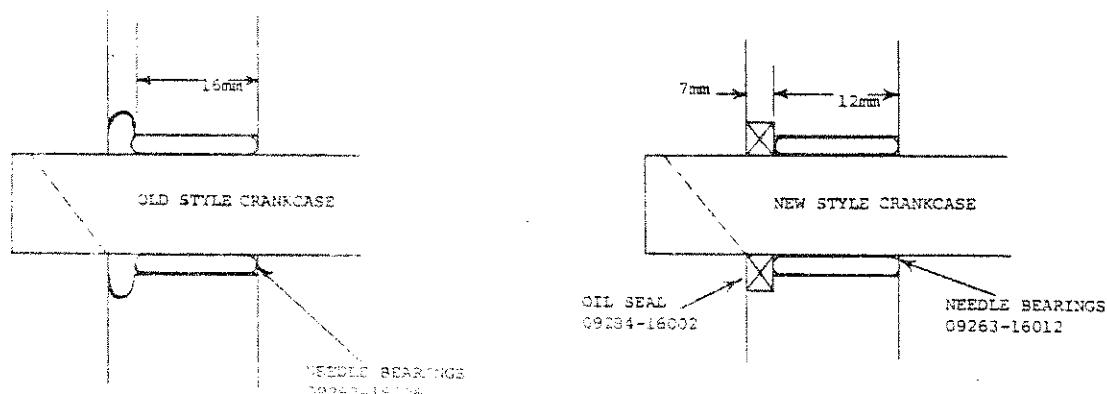
To strengthen the GT380/550/750's gear shift indicator switch's body, its material has been changed from phenolic to metal, and its shape changed.

At the same time, the crankcase has been changed to accept an oil seal for the gear shifting camshaft. This will prevent metal particles in the transmission oil from damaging the switches' "O" rings, thus allowing oil to seep past. The crankcase modifications are listed below:

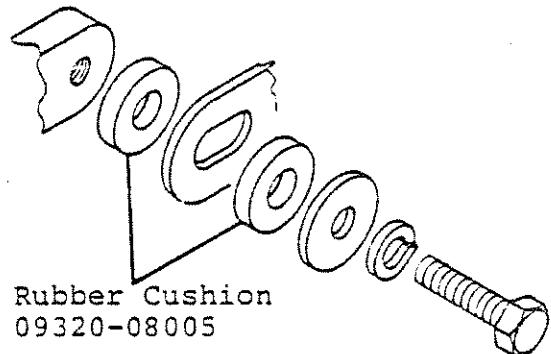
Rubber Cushion
09320-08005TYPE 1

The Type 1 method is a "semi-floating" mount. A rubber cushion is used with the original type fender to provide a small amount of flexibility. With this type of mount, the mounting bolt must be secured with thread lock cement.

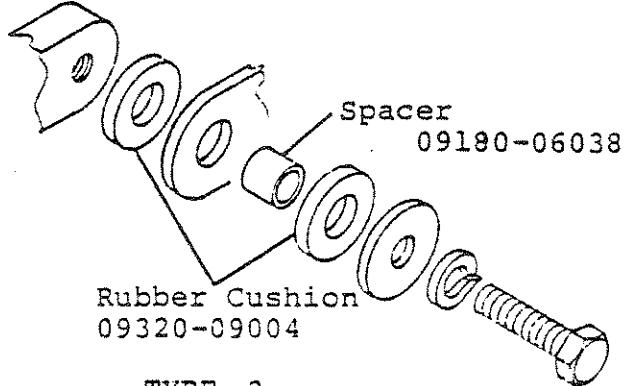
Rubber Cushion
09320-09004Spacer
09180-06038TYPE 2

The Type 2 method is a "floating" mount. The front fender brace has been changed and it is mounted by a rubber cushion and a spacer. This mounting method will provide a secure yet flexible mount for the front fender.

There are presently three ways to mount the A and B model GT500 front fender brace to the front fork outer tube. To distinguish the different mounting methods from each other, they are labeled the Original method, the Type 1 method, and the Type 2 method. If any original or Type 1 front fender has to be replaced, it must be updated to the Type 2 fender.

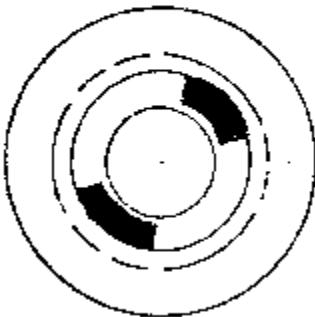
We have received reports of broken GT 185 oil pump drive gears.

OLD STYLE WITH
TWO ENGAGEMENT DOGS

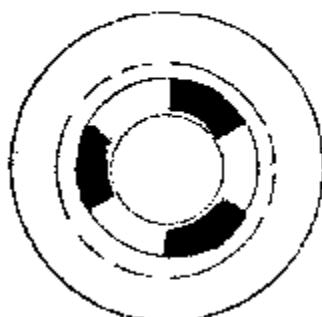
NEW STYLE WITH
THREE ENGAGEMENT DOGS

To increase the durability of the oil pump drive gear, the number of engagement dogs have been increased from 2 to 3.

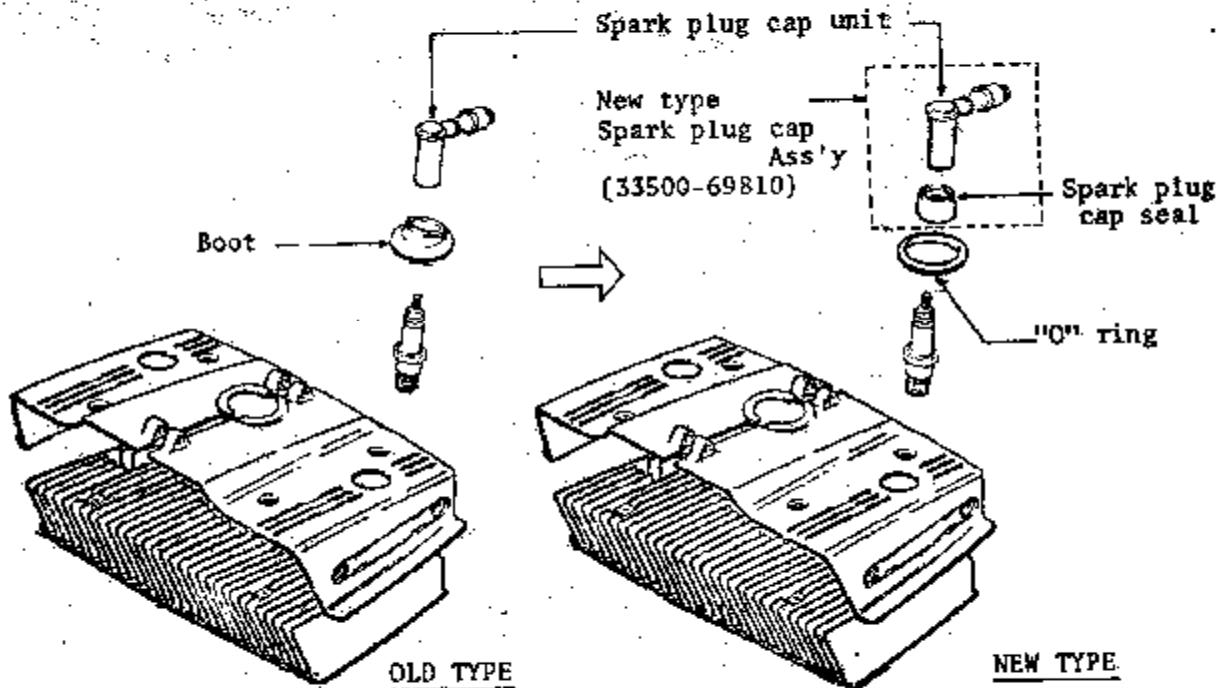
This bulletin is intended to inform you that the spark plug cap sealing has been modified into a conventional type in order to prevent a high tension leak from the spark plug cap.

In this modification, the spark plug boot has been removed and an "O" ring has been fixed to the cylinder head cover. No modification has been carried out in the cap unit itself.

Caution: In case of any engine trouble due to leakage of electricity from the spark plug cap (mis-firing of the engine), the plug cap should be changed to the new type and at the same time an "O" ring should be fixed to the cylinder head cover.

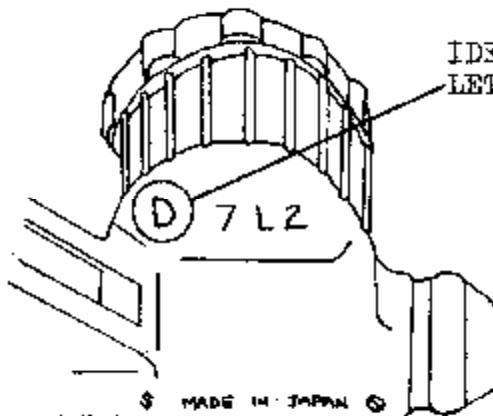
For GT750K

As the misuse of the master cylinder may bring about poor brake performance or the improper brake lever stroke, careful attention should be paid not only to the part number stamped on the paper tag but also to the identification marking on the cylinder which is:

Piston Diameter: 15.9 mm
Part No. 59600-31040

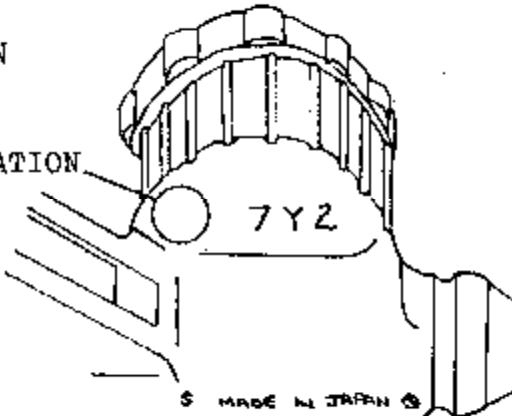
Piston Diameter: 14 mm
Part No. 59600-18840
For GT250K, GT380K, GT550K.

So, please note, an identification letter "D" is press stamped on the cylinder for the double disc type and no identification marking for the single disc type. Disregard any letters cast into the cylinder as they do not apply in this case.

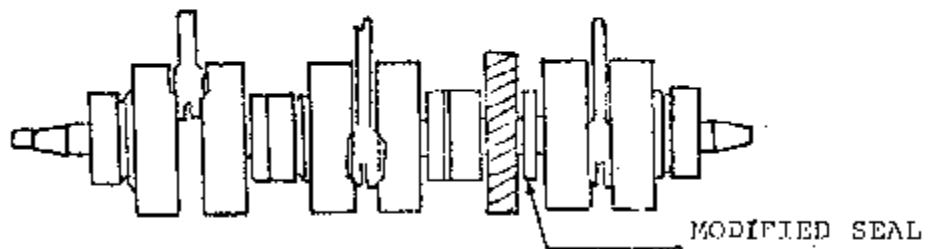
The excessive smoking was attributed to the right inboard crankshaft oil seal becoming displaced, allowing transmission oil to pass into the right cylinders crankcase.

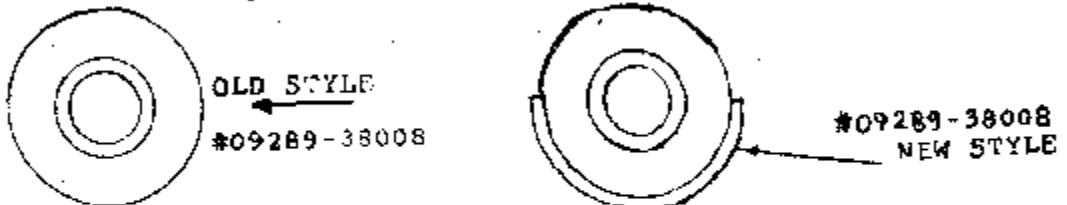
To provide a more positive method of positioning the right inboard oil seal, a metal flange has been added to the seal.

The new style seal's flange eliminates the old style seal's positioning "C"-ring (Part No. 09390-78003). The flange of the oil seal should be placed in the "C"-ring's crankcase groove when positioning the crankshaft assembly in the lower crankcase half. Only the new style oil seal (#09289-38008) will be supplied from the parts department.

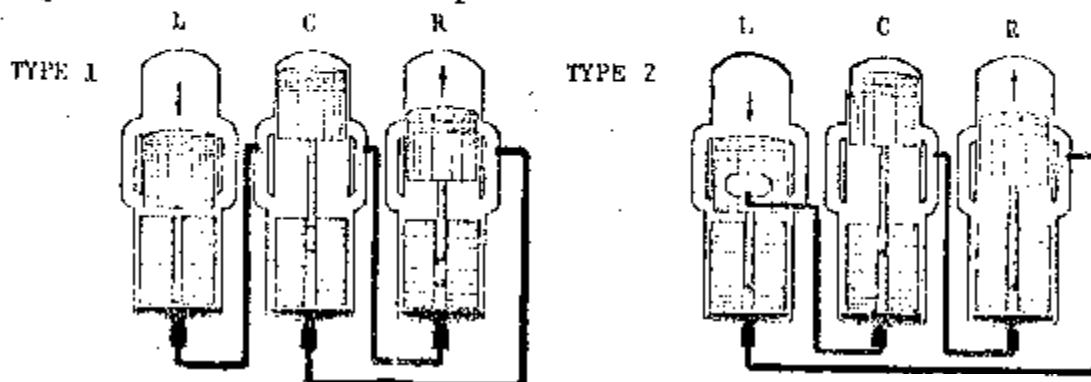
As explained in the Service Manual of GT750, there are two types of the SRIS piping shown below and the type 2 in the illustration has been applied to the production since just before the yearly change of 1973 and the initial number of the modified engine is GT750-31344

The reason for this modification is to rectify the symptom that the engine of the type 1 tends to emit a little thick fumes from the right hand muffler as compared with the others

This symptom only appears when the engine is not warmed up enough and it in no way affects the engine function. However, it is supposed that the users who mainly drive the motorcycles in town or at rather low speeds might point out this problem and request you to correct it.

In order to provide for this request, a modification kit has been prepared to convert the early engine to the new type in principle and it now available as a spare part.

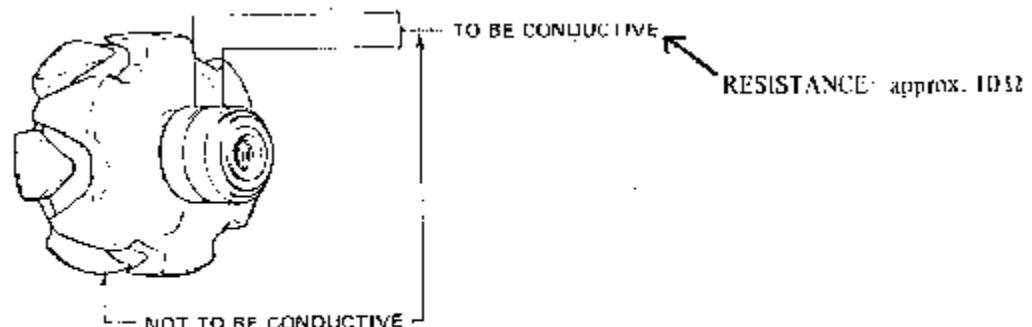
The early rotor coil was wound on a plastic bobbin then taped outside and fitted between the rotor poles with no space allowed for expansion of the coil windings when warm. The new type have their coil wound loose, then taped all around in the same manner as a new tire is wrapped. The coil is fitted with a felt spacer to allow the windings to expand and contract.

Before condemning a rotor, check its continuity from brush ring to brush ring using an ohmmeter, (Suzuki Pocket Tester, reading: 10* resistance) or a battery with a lamp, there should be conductivity. From either ring to the rotor body, or ground, there must be no continuity. Do not change the rotor point blank, as the problem could be in the voltage regulator, the rectifier, the wiring, or the battery itself.
