SERVICE BULLETIN

SUBJECT: BATTERYS NOT CHARGING
Affected Models: Three Cylinder Models
Effective Engine No.: Before E.#'s GT380-38764
Reference: GT550-27536 & GT750-33504

Bulletin No. 137
Date June 11th 1973
Page 1 2

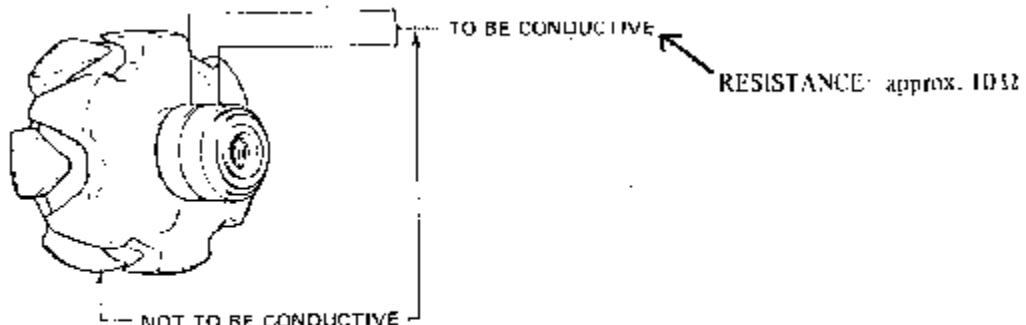
Before condemning a rotor, check its continuity from brush ring to brush ring using an ohmmeter, (Suzuki Pocket Tester, reading: 10* resistance) or a battery with a lamp, there should be conductivity. From either ring to the rotor body, or ground, there must be no continuity. Do not change the rotor point blank, as the problem could be in the voltage regulator, the rectifier, the wiring, or the battery itself.
