**SUZUKI****Rotary**

Service Bulletin Index

U. S. SUZUKI TECHNICAL SERVICE

Bulletin No. RE-1
 Date DECEMBER 20, 1974
 Page 1 of 3

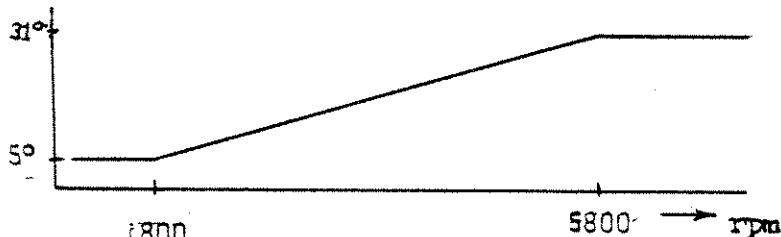
ADVANCE INDICATOR LINES

When checking the ignition timing advance, use the longest line shown in the illustration for setting the pointer wire to it referring to the idling ignition timing; the line next to it (obsolete line) will give 4 degrees difference from the specification.

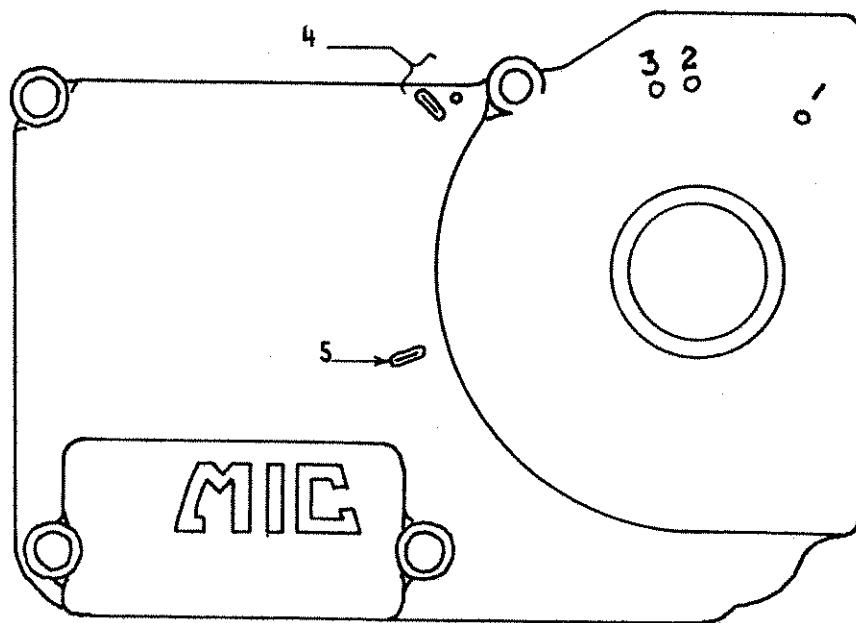
fig 2

- 1. = 0°
- 2. = 22.5°
- 3. = 35°
- 4. = If dot and dash use dot 36°
If only dash = 36°
- 5. = 82°

11. The accelerator pump may now be checked in accordance with the service manual.
12. Remove the port valve cover. Turn the throttle grip until the long arm of the indicator aligns with the 36° mark, #4 shown in fig. 2. If there is a dot and a dash use the dot. If there is only a dash, use it.
 - a. If the tab of the port valve cable pulley has not reached the port valve lever, turn adjuster P3 out until the tab on the cable pulley just contacts the port valve lever.
 - b. If the port valve begins to open too soon and adjuster P3 is all the way in, this indicates that adjuster P1 is adjusted out too far. It must be turned in and the procedures 6-12 must be re-done.
