Early T500 Turn Signals

Four types are shown - the very early style having a stem clamp and flattened rear housing, no stem clamp but with flattened rear housing, round back and no stem clamp, and then the ones commonly sold as NOS having long stems and incorrect wire routing.

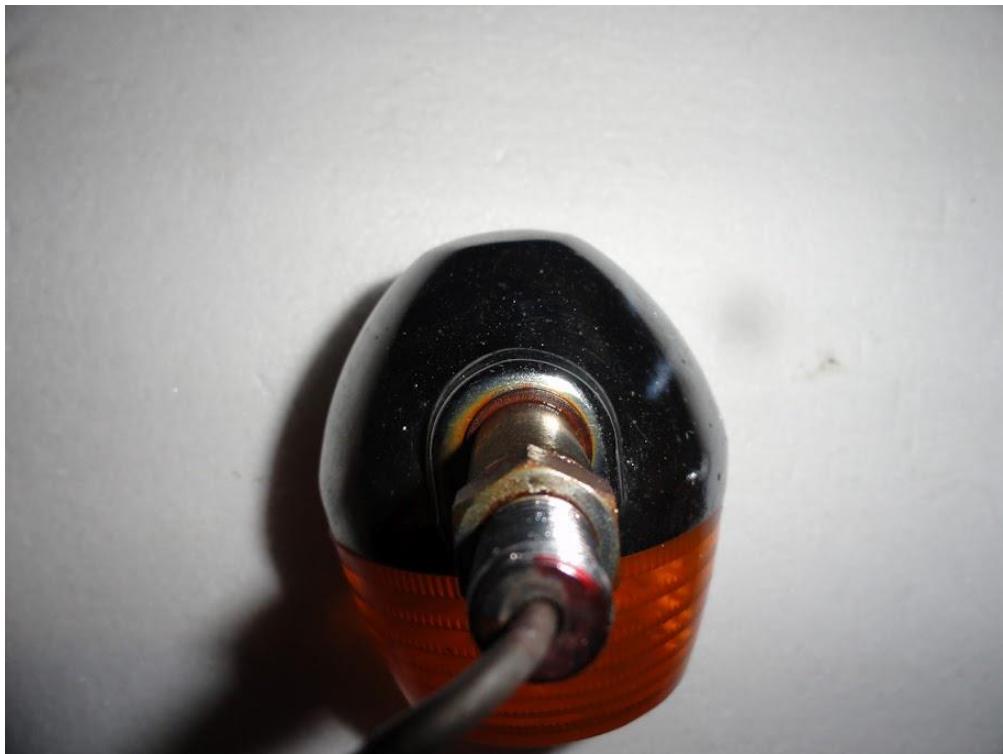
The photo below is of the front signal from a 1969 T500-II. Notice that the back of the signal housing is flat, there is no stem clamp, and that the stem is quite short - about 1 inch long, excluding the threads.

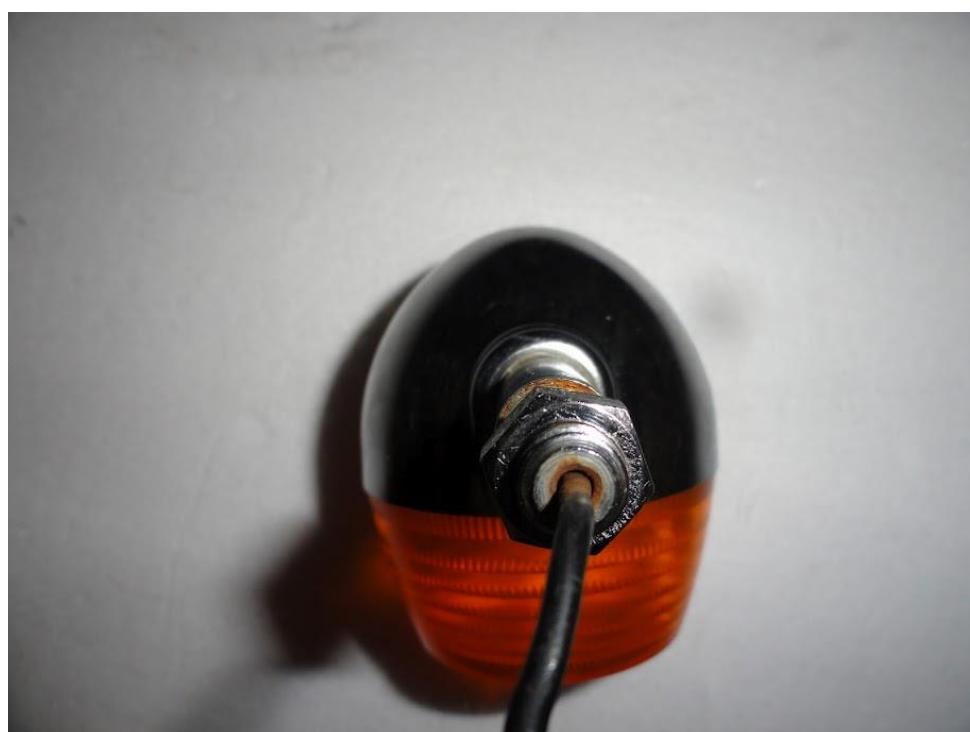
A similar front signal, but with a rounded end. The stem is about the same length as the one having the flat end, an no stem clamp.

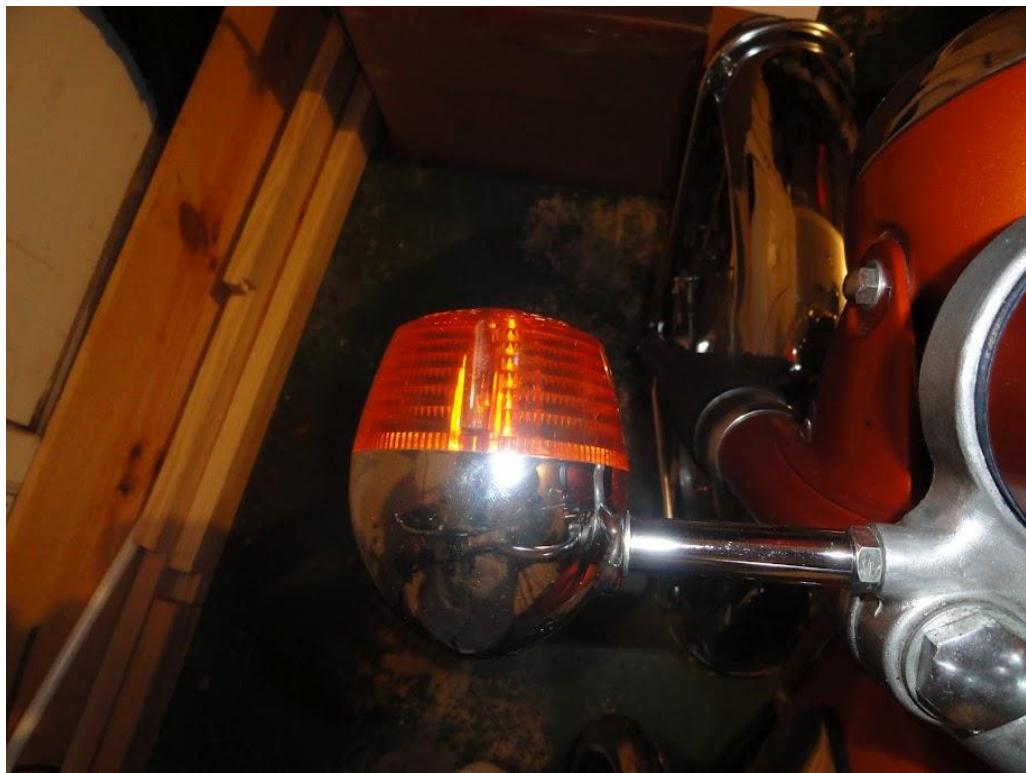
In the photos below, on the left is what is commonly sold as NOS and has a long stem - about 2.25 inches long - and no stem clamp.

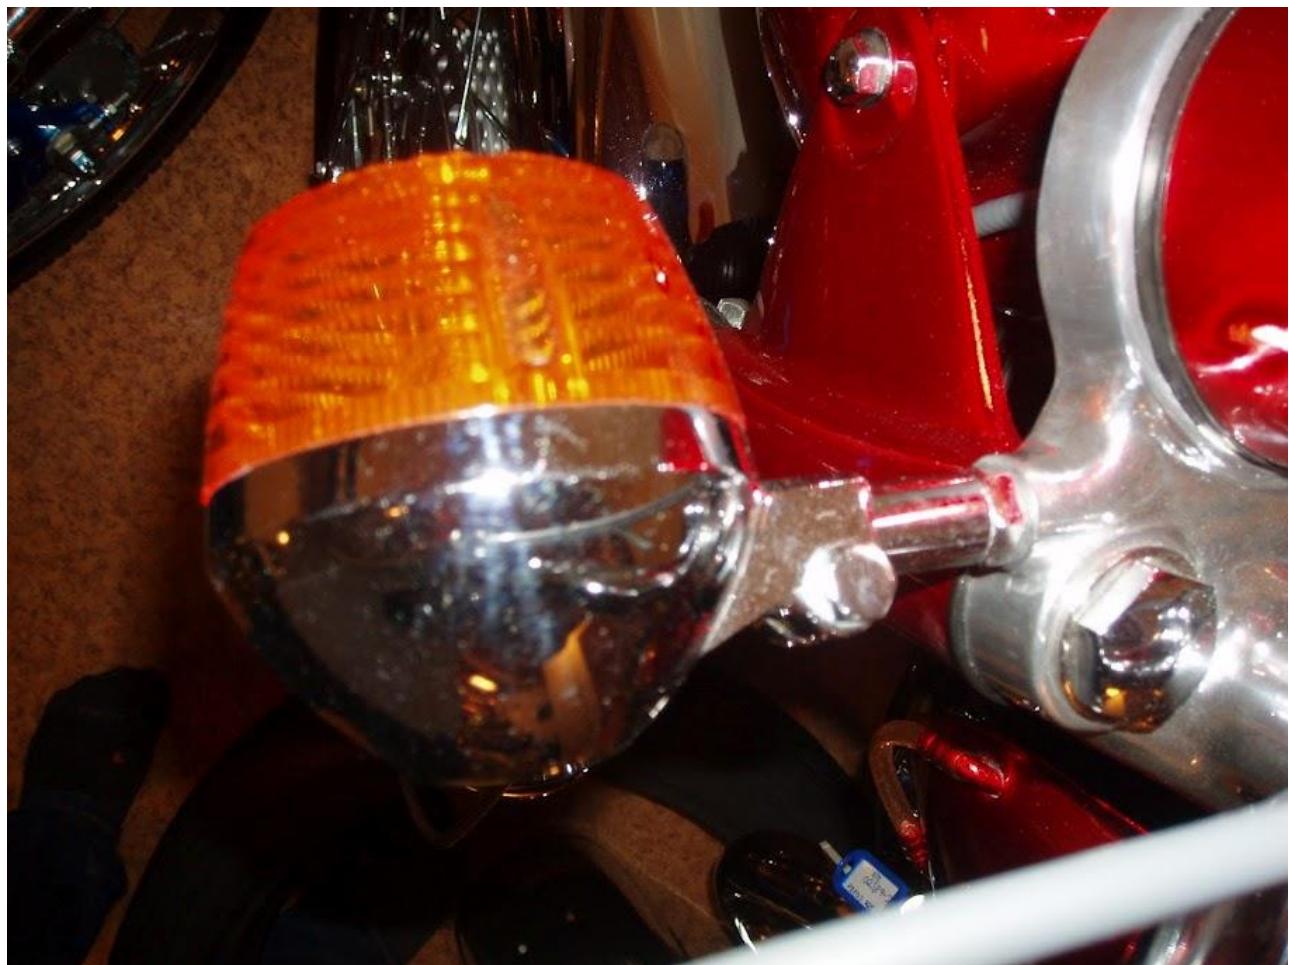
Below that is the correct signal for the early T500's having the short stem, stem clamp and flat end.

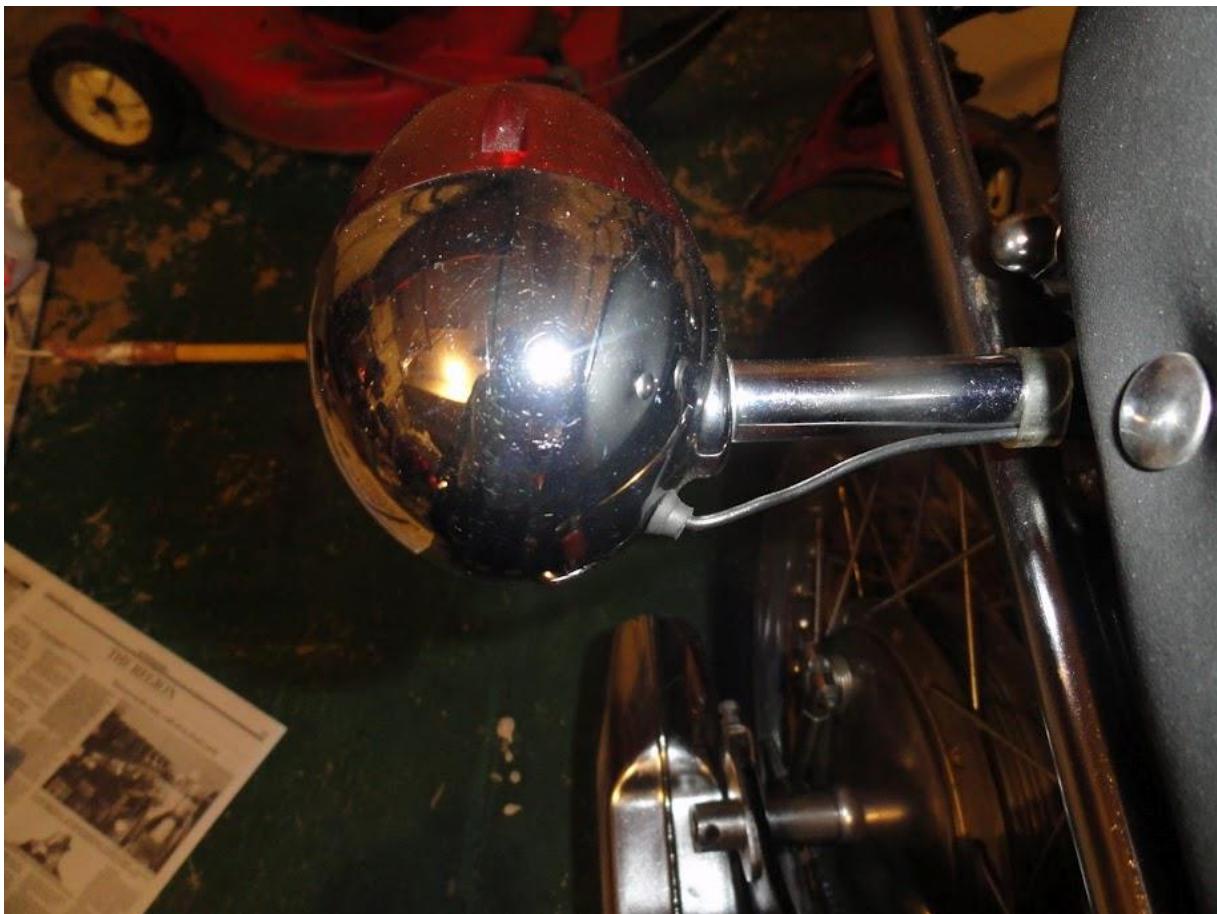
Likewise for the rear signals - the photo on the lower left is of what is commonly sold as NOS and has the long 2.25 inch stem with the wire on the outside, rear of housing is round, and no stem clamp. Below that is a photo of the correct signal for the early T500's with the wire threaded inside the stem and the external stem clamp
